INSPECTION REPORT

Inspection Date: 3/5/2019

Inspected By: Fortunato Enriquez, PE
Dokken Engineering

Bridge Name: Arroyo Trabuco

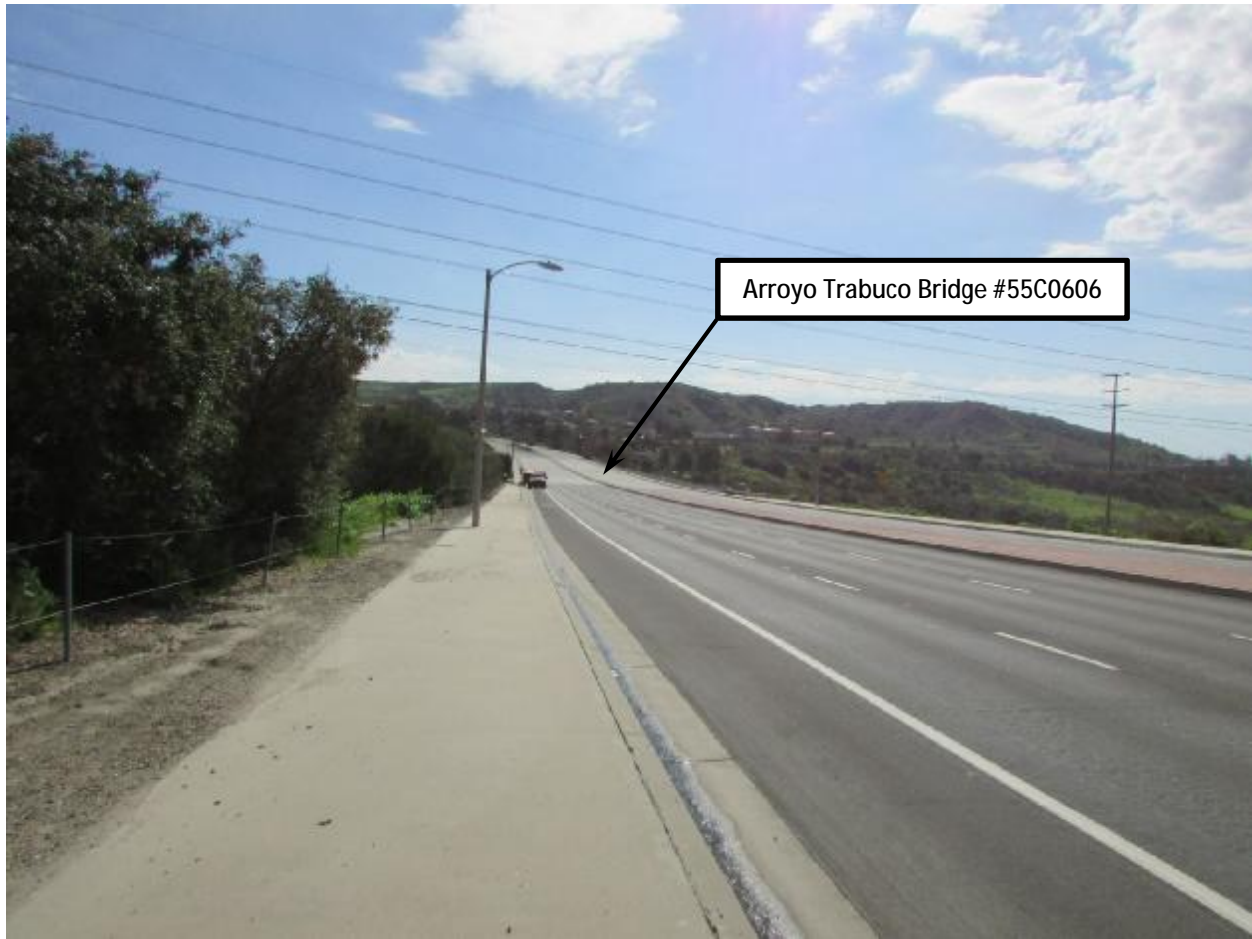
Photo 1: Oso Parkway Facing Southeast. Arroyo Trabuco bridge is located at the low point of Oso Parkway.

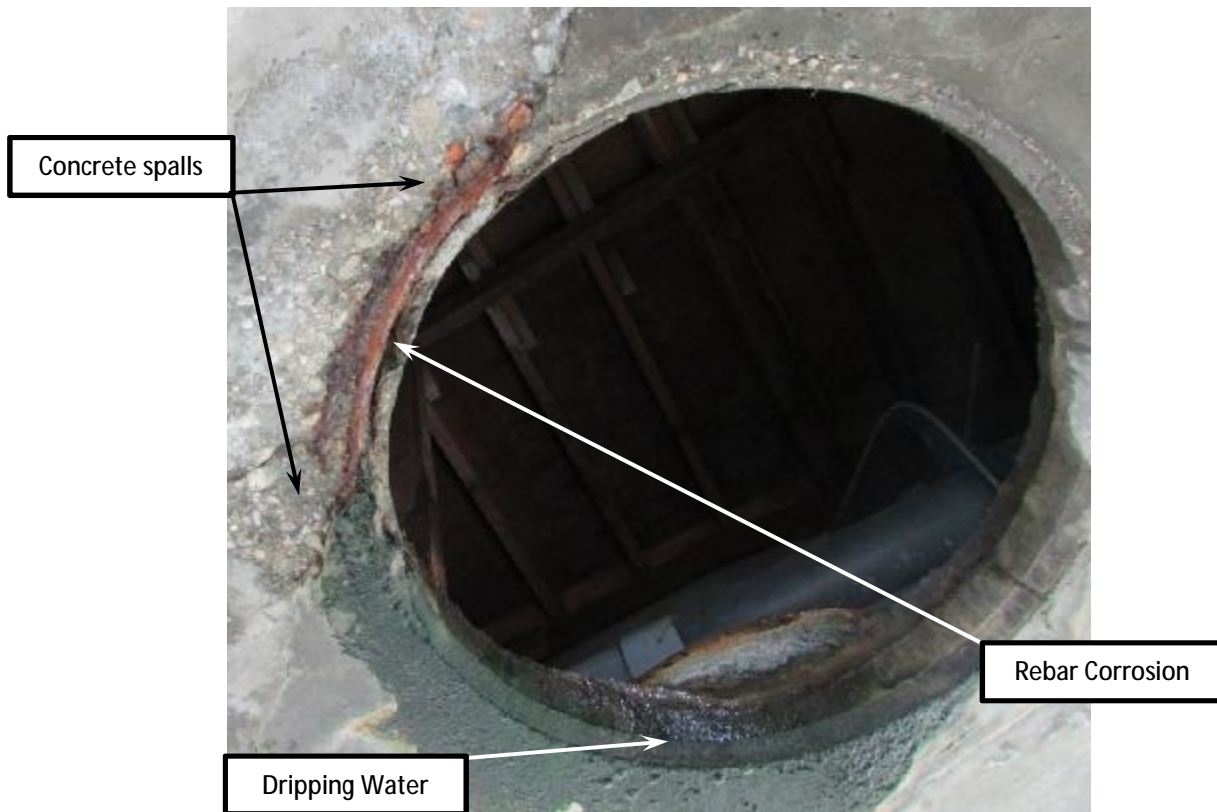
The stagnate water in the bridge is seeping through the bridge soffit which is causing the reinforcement to oxidize and expand. The oxidized rebar will sequentially cause the bridge soffit to crack and spall.

Photo 2: Spalling around the soffit opening as well as rebar corrosion.

Dokken Engineering recommends Orange County contact the San Diego Gas & Electric (SDG&E), to determine the origin of the water and begin the process to repair damage caused by water entering the bridge.

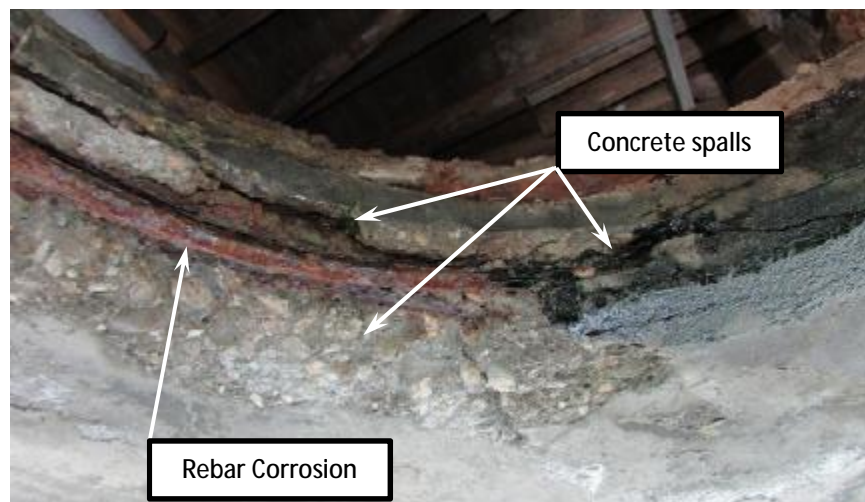
Photo 3: Spalling around the soffit opening.

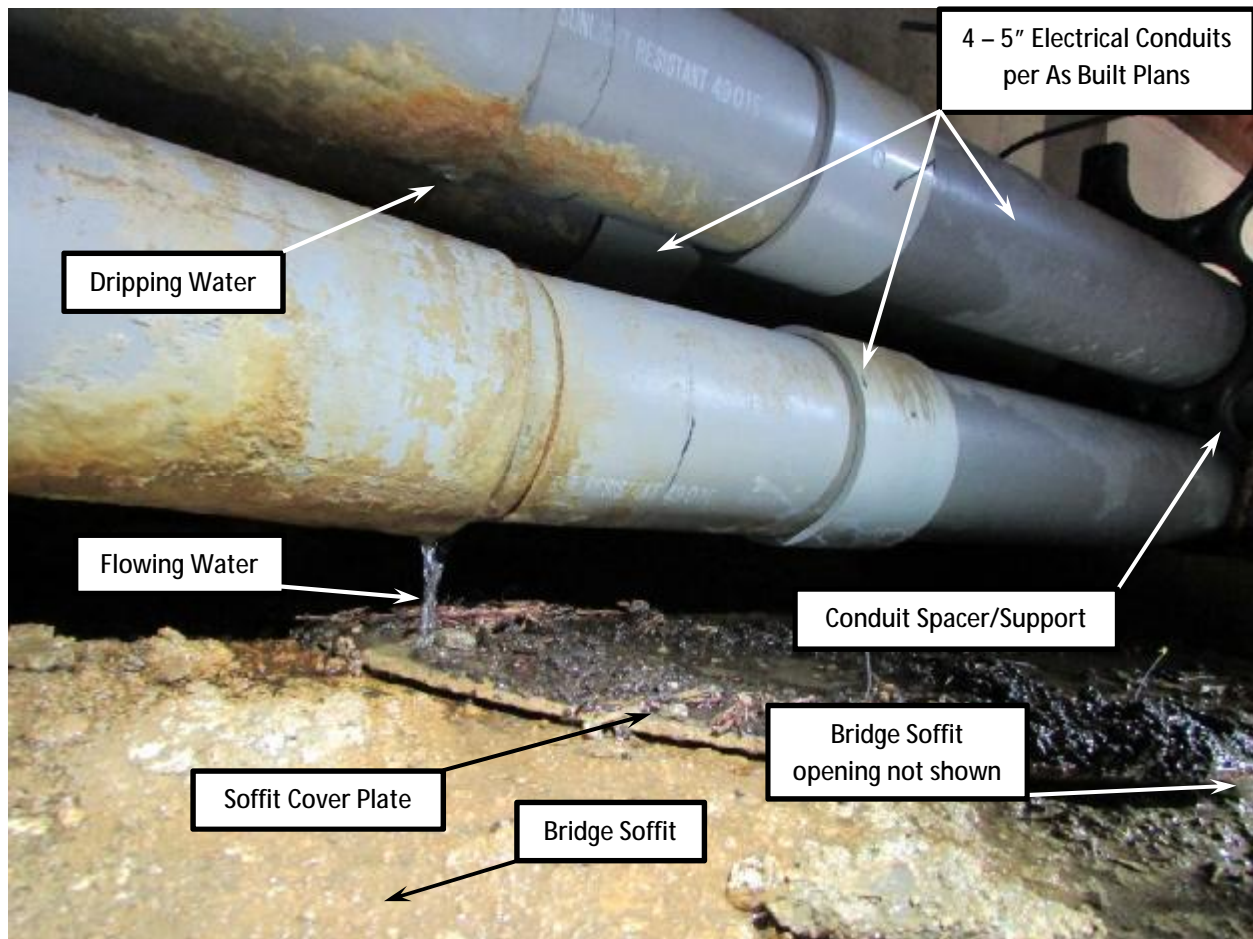
Photo 4: A steady flow of water exiting the electrical conduits.

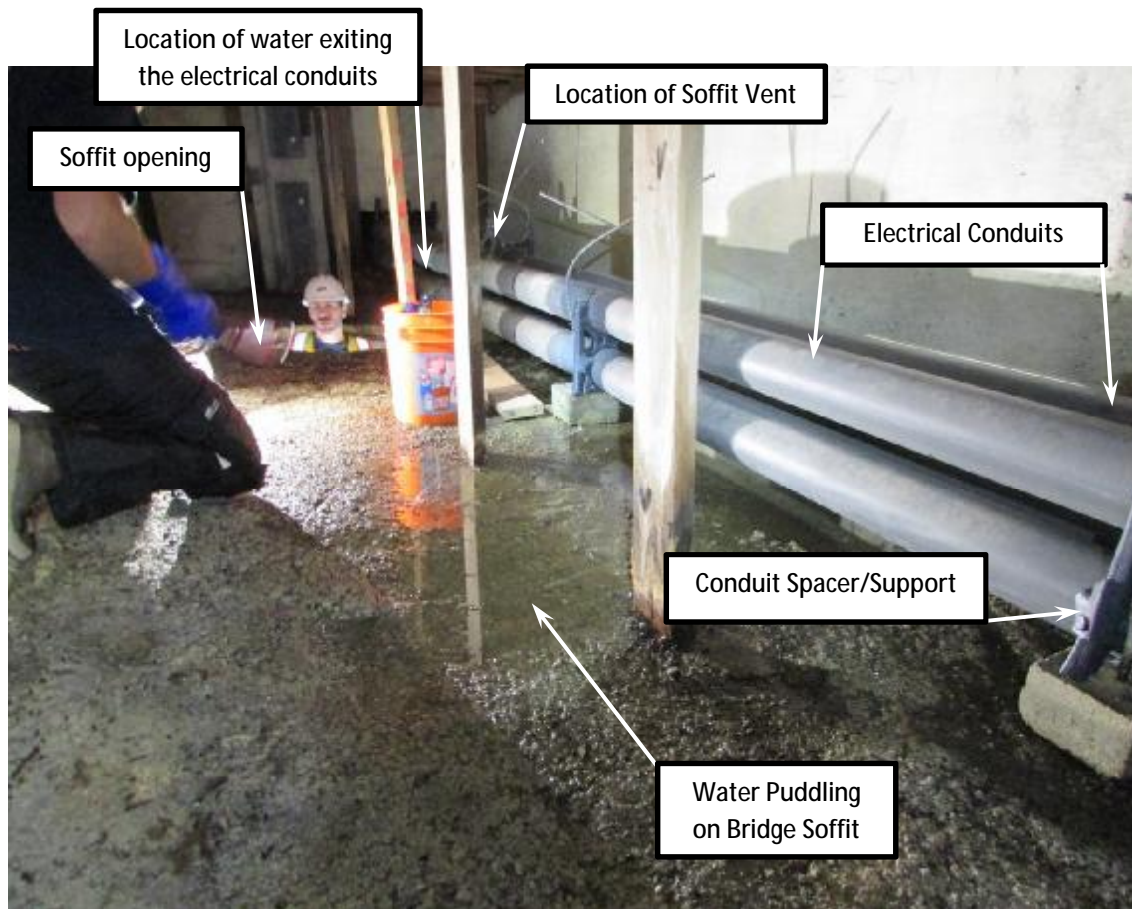
Photo 5: Water puddling around the electrical conduit.

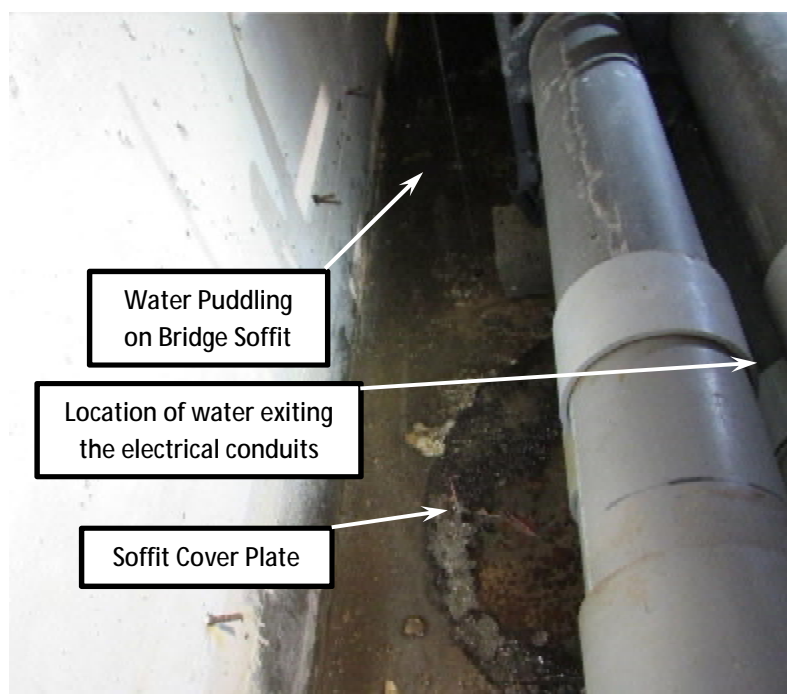
Photo 6: Water puddling around the electrical conduit.

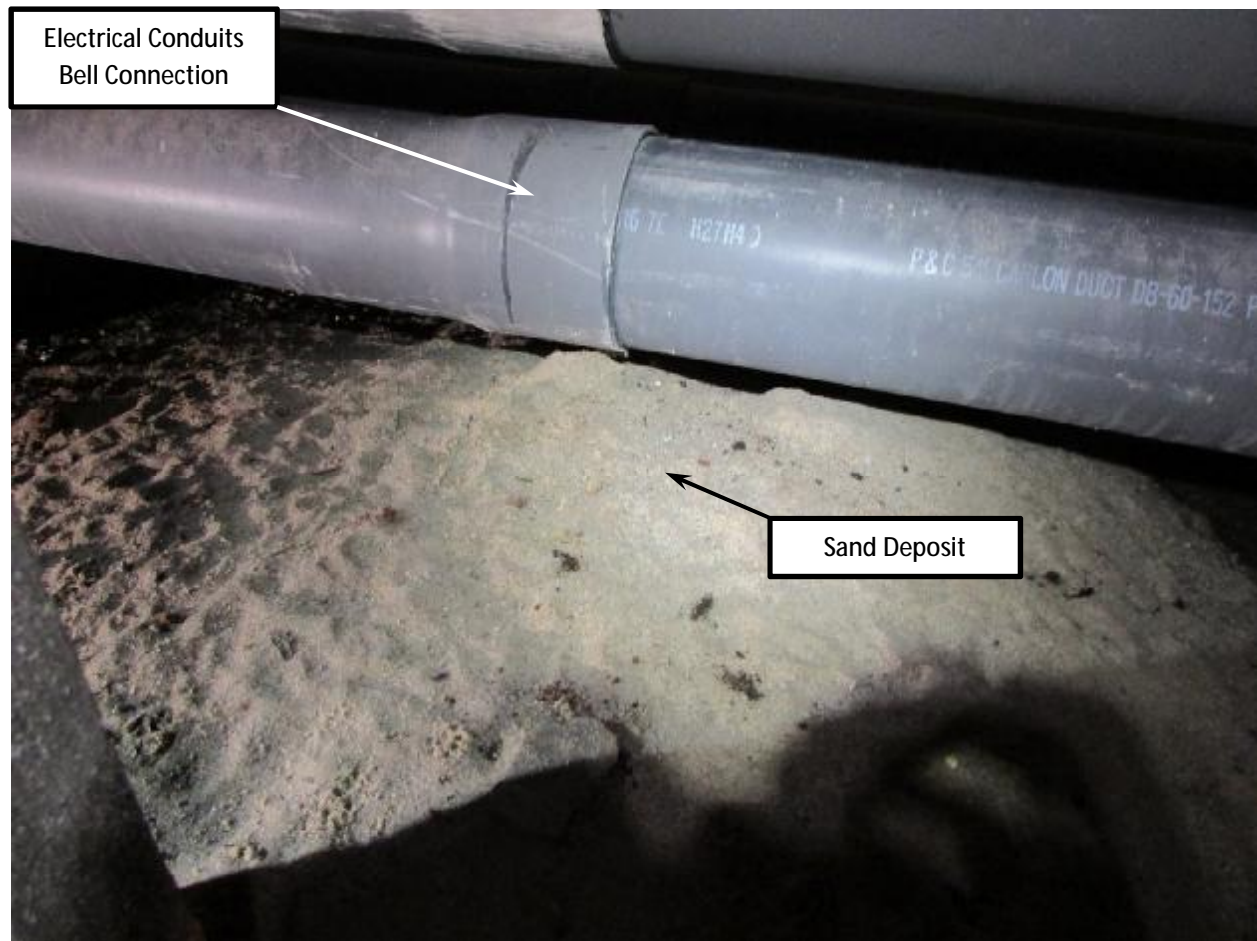
Photo 7: Deposited sand within the bridge cell. Sand is not typically found inside box girder bridges.

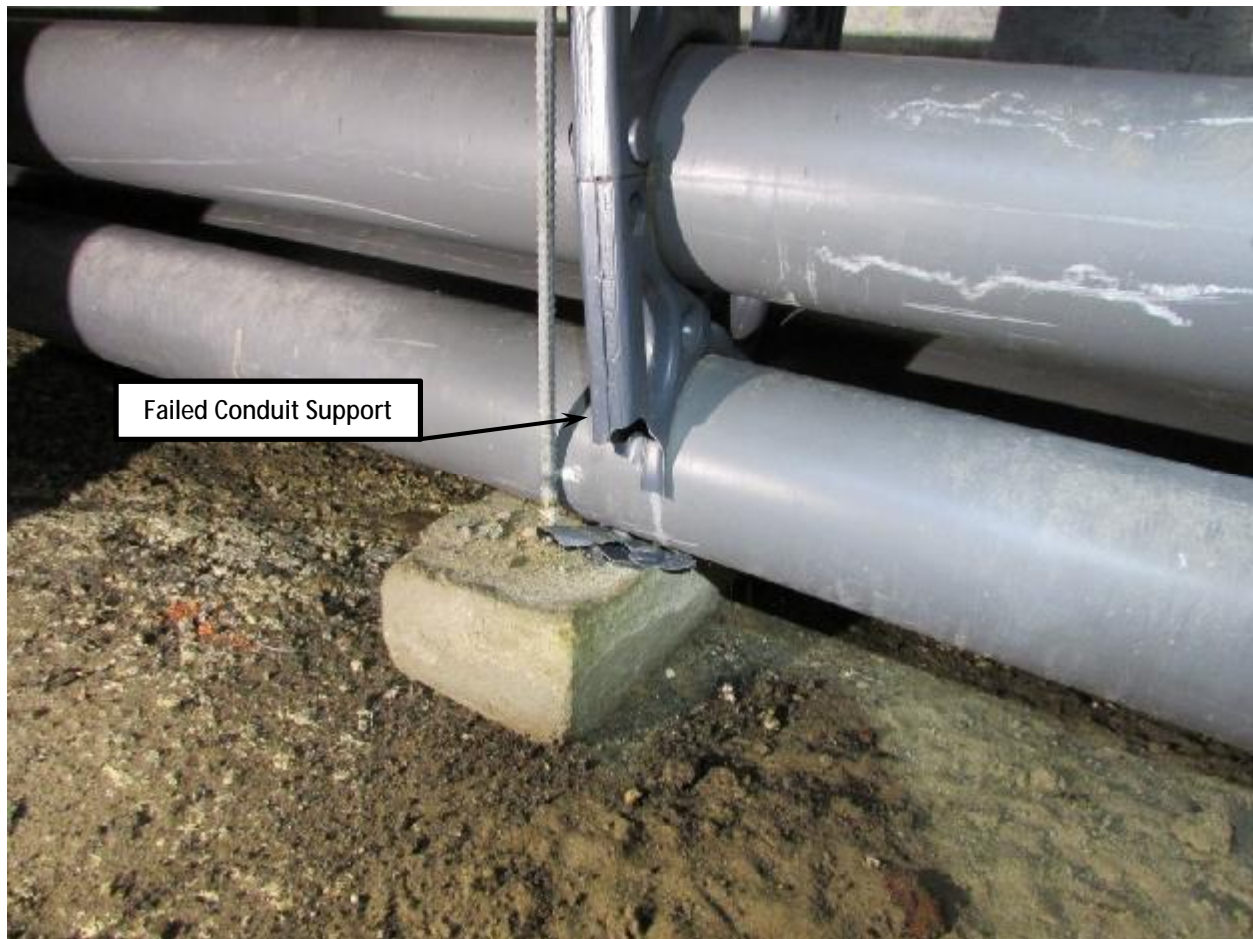
Photo 8: Failed conduit spacer/support likely caused by excessive loads.

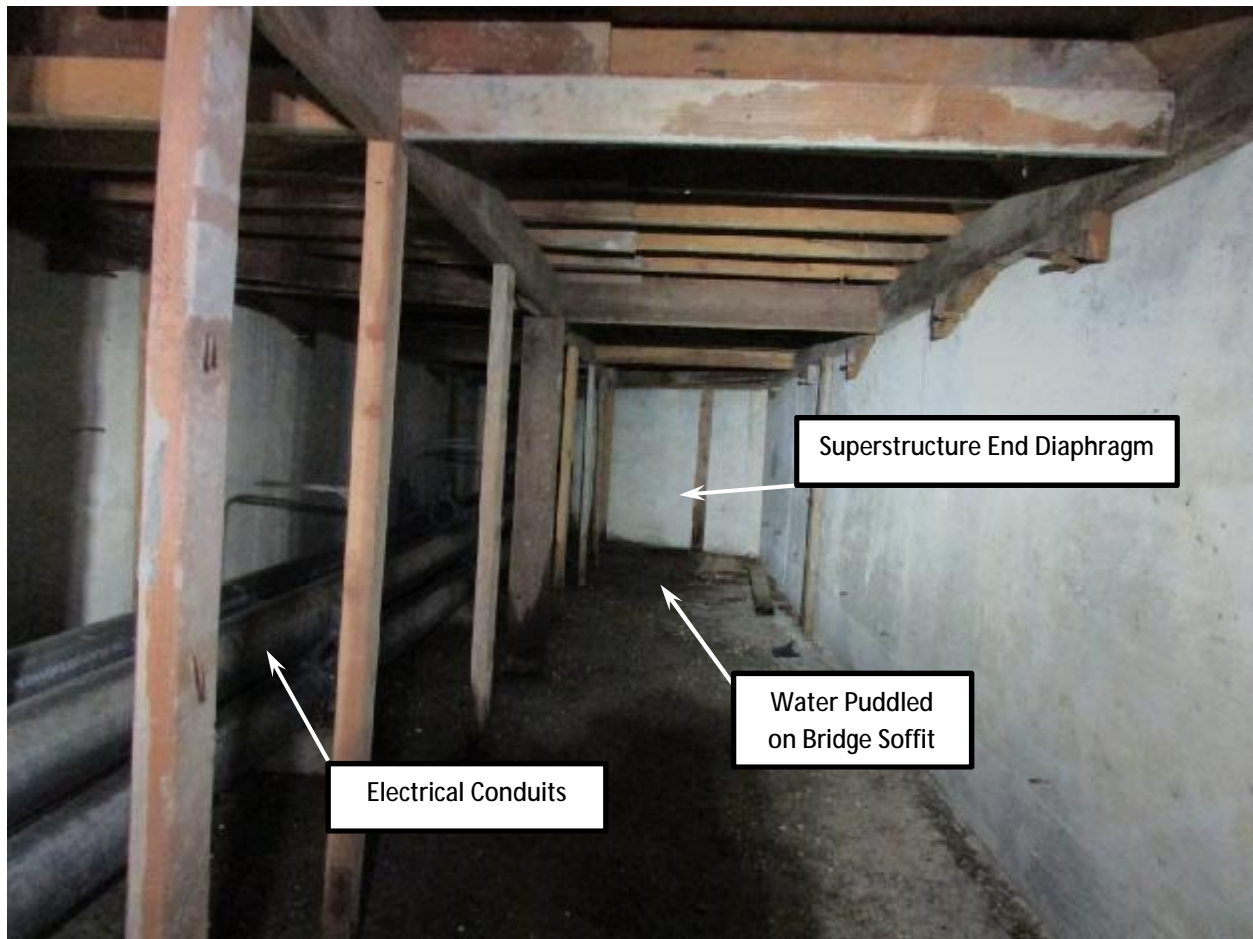
Photo 9: Puddled water by the superstructure diaphragm. There was no indication of water coming from the electrical conduits at this location.

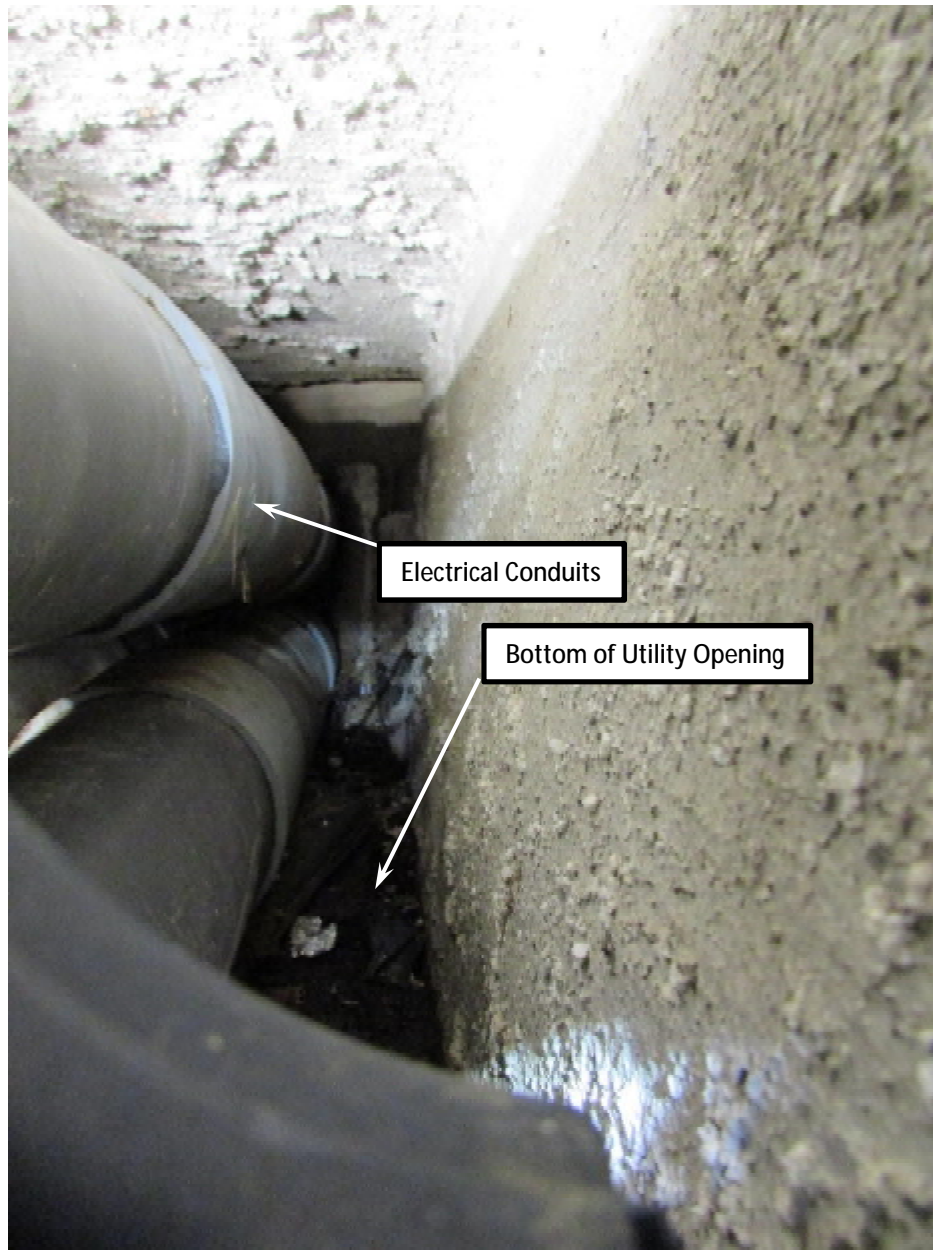
Photo 10: Utility opening through the superstructure diaphragm. The bottom of the utility opening was damp. There was no indication water was leaking from the electrical conduits at this location.
