Orange County Bridge Review Summary

Bridge Number: 55C0629

Bridge Name: Wildlife Undercrossing

Facility Carried: Antonio Parkway

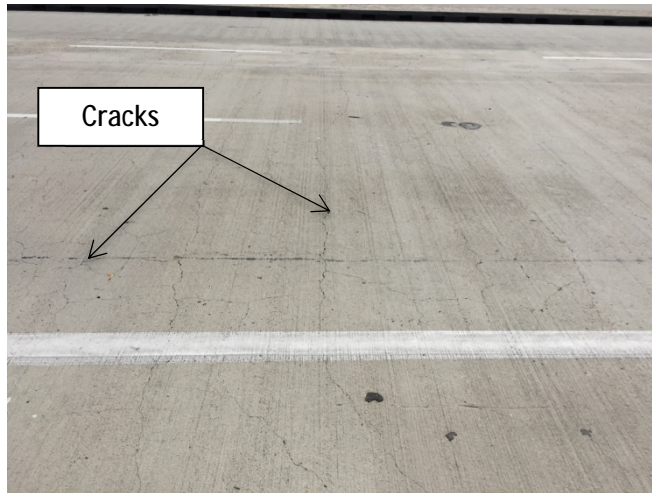
- Minor deck cracking observed. No action needed.

Photo 4: Bridge Deck
