Orange County Bridge Review Summary

Bridge Number: 55C0631

Bridge Name: Santa Anna River Channel

Facility Carried: Harbor Boulevard

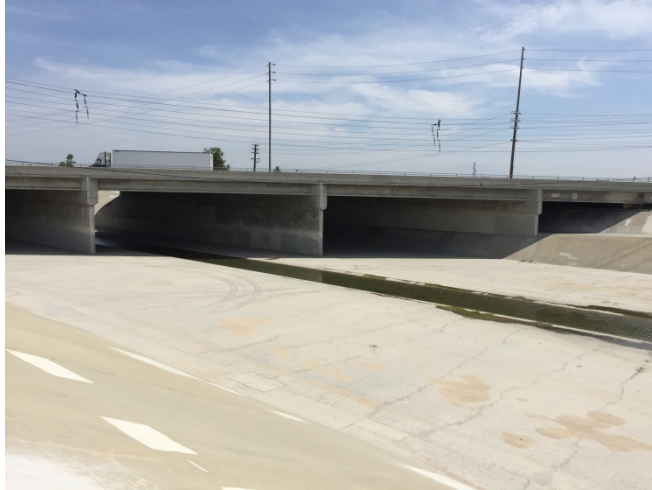
Photo 1: Santa Anna River Channel

- Plugged drain inlets.
- Efflorescence visible on the bridge soffit (photo 1). Per site inspection it appears the bridge deck has been treated. Need to confirm with OCPW.

- N/A – No eligible maintenance activities, unless bridge deck has not been treated. Treating the deck is eligible for BPMP funding since deck is condition state 2.

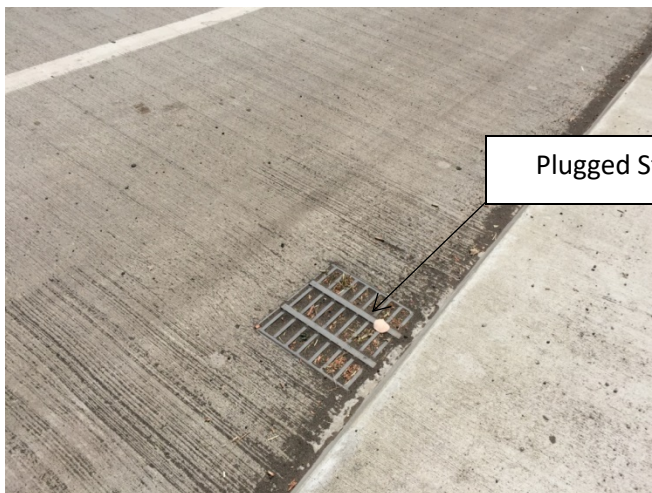
- Clean clogged drains

Photo 3: Deck Drain

- Clean clogged drains.

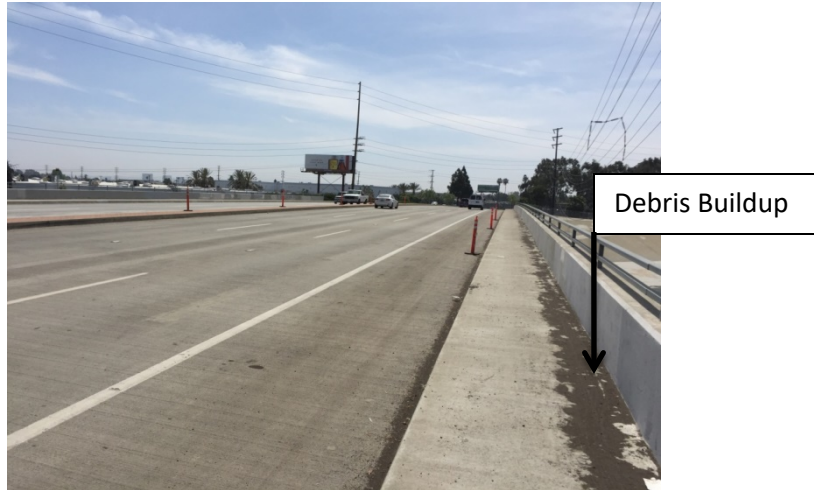
Photo 4: Sidewalk

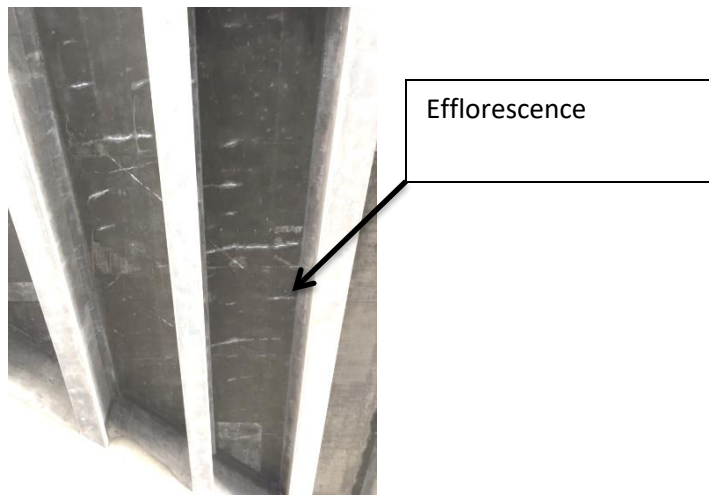
Photo 5: Bridge Soffit
