Orange County Bridge Review Summary

Bridge Number: 55C0637

Bridge Name: Arroyo Trabuco

Facility Carried: Crown Valley PKWY

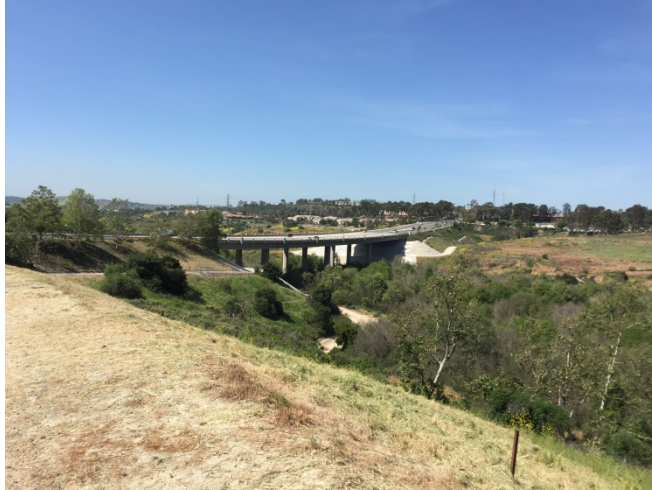
Photo 1:

- There is efflorescence visible on soffit near the soffit opening cover plate which is heavily corroded. Water leaking/dripping in span 1, this appears to be a water line.
- Torn joint seal (photo 1).

- Repair joint seal assembly.

- Recommend contacting utility owner of water line. Note this will not eligible for BPMP funds but should be covered by the utility owner.

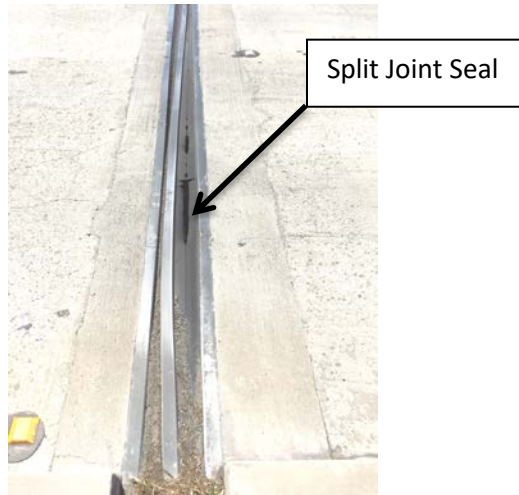
Photo 7: Joint Seal

- Weld back the sheared off middle steel bar of the joint seal assembly. (From 2013 BIR, although not repaired not in 2015 BIR).
- Clean out all dirt and debris in all joint seals.

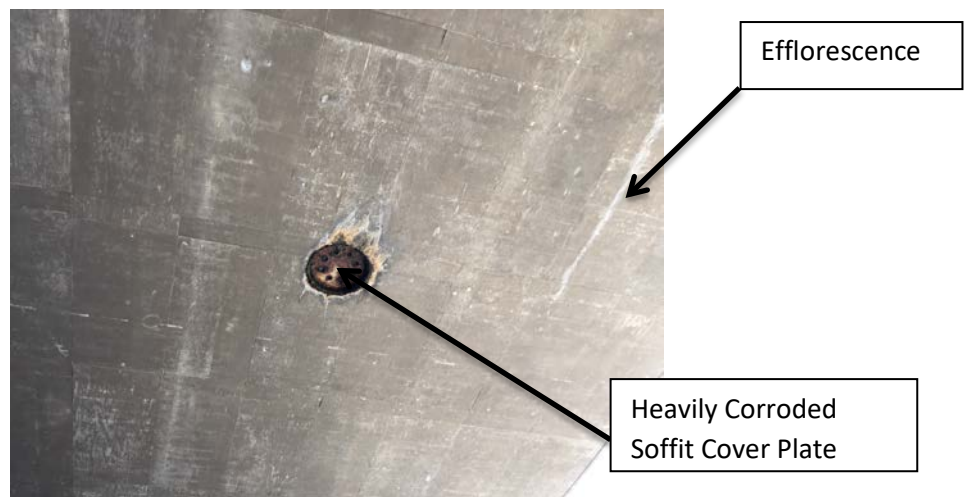
Photo 8: Bridge Soffit

The county has to check the utility pipes inside the box cells where the soffit access is leaking water and the cover place is heavily rusted and corroded in span 4.

- Utility repair should be funded by utility company
- Soffit cover plate replacement
