# Access Compliance Report Public Rights-of-Way (Island Curb Cuts)

Main Street:OSO\_PKWY Cross Street:ANTONIO\_PKWY Location: NW

ADA ID: CCAT220208132212 Curb Cut Type:IslandRefuge3 Initial Pass/Fail: Pass Overall Compliance: No Severity Score: 50

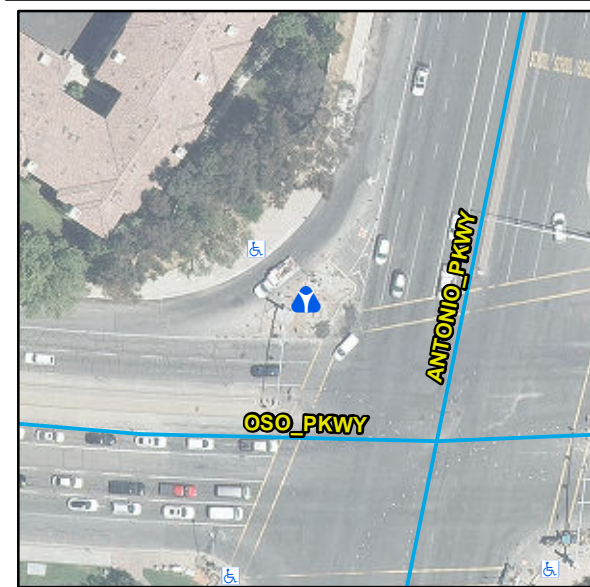
Surveyor Notes:  
**N/A**

Possible Solutions:  
**Install Detectable Warning System. Restripe Crosswalk. Remove & Replace Gutter.**
