## **Access Compliance Report Public Rights-of-Way** (Island Curb Cuts)

Main Street: O\_NEILL\_DR Cross Street:O\_NEILL\_DR Location:

ADA ID: CCRK211102131219 Curb Cut Type: MedianRefuge2 Initial Pass/Fail: Fail **Overall Compliance: No Severity Score:** 15

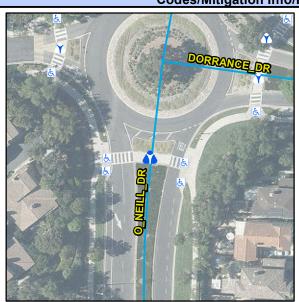
R302.6, STD 1115

Possible Solutions: Remove & Replace Entire Refuge.
