# Access Compliance Report Public Rights-of-Way (Island Curb Cuts)

| Main Street: ETHEREAL_RD | | Cross Street: ETHEREAL_RD | | Location: | N |
| ADA ID: CCRK211103162342 | Curb Cut Type: MedianRefuge2 | Initial Pass/Fail: Pass | Overall Compliance: No | Severity Score: | 15 |

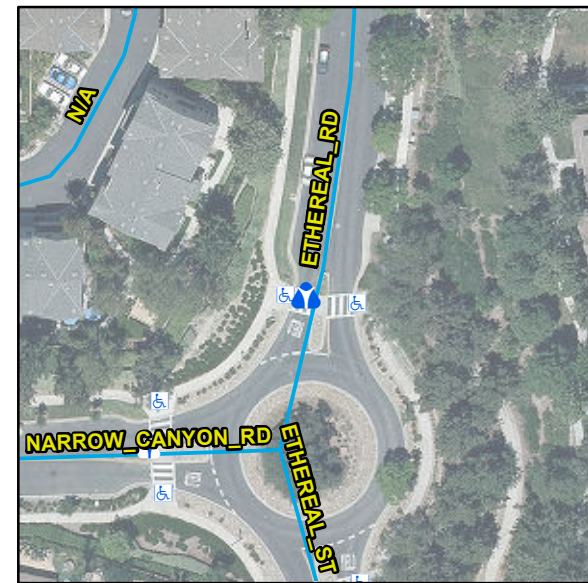
| Compliance | Description | Data | Compliance | Description | Data |
|---|---|---|---|---|---|
| N/A | Painted Cross Walk 1 | Yes | No | DWS 1 Provided | No |
| N/A | Painted Cross Walk 2 | Yes | No | DWS 2 Provided | No |

Possible Solutions:

Install Detectable Warning System.
