# Access Compliance Report Public Rights-of-Way (Island Curb Cuts)

| Main Street: DORRANCE_DR | | Cross Street: DORRANCE_DR | | Location: | W |
| ADA ID: CCRK211110130817 | Curb Cut Type: MedianRefuge2 | Initial Pass/Fail: Pass | Overall Compliance: No | Severity Score: | 15 |

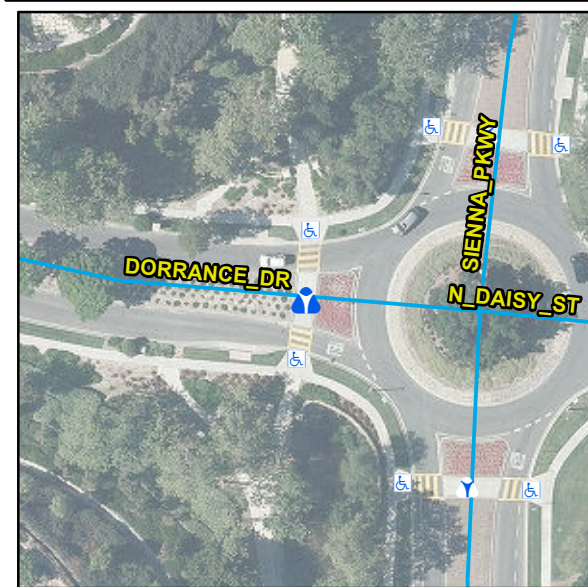
| Compliance | Description | Data | Compliance | Description | Data |
|---|---|---|---|---|---|
| N/A | Painted Cross Walk 1 | Yes | No | DWS 1 Provided | No |
| N/A | Painted Cross Walk 2 | Yes | No | DWS 2 Provided | No |

Install Detectable Warning System.

R305, STD 1115
