# Access Compliance Report Public Rights-of-Way (Island Curb Cuts)

| Main Street:SENDERO_WAY | | Cross Street:SENDERO_WAY | | Location: | NE |
| ADA ID: CCRK211117153011 | Curb Cut Type:MedianRefuge2 | Initial Pass/Fail: Pass | Overall Compliance: No | Severity Score: | 15 |

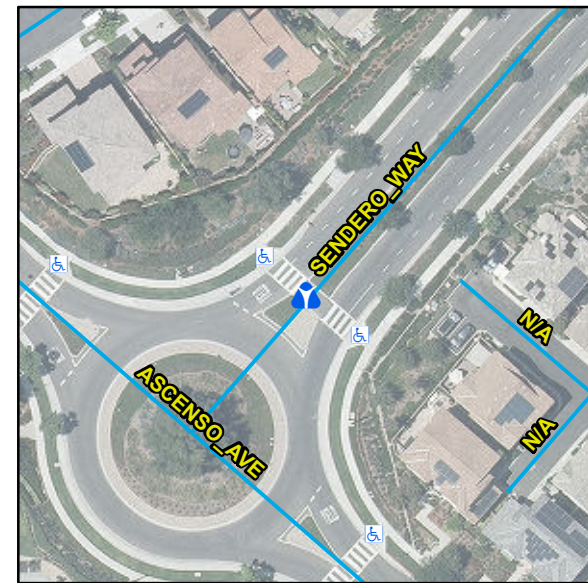
**R305, R304.5.3, STD 1115**

**Install Detectable Warning System. Remove & Replace Gutter.**
