Access Compliance Report Public Rights-of-Way (Island Curb Cuts)

Main Street: REATA_RD Cross Street: REATA_RD Location:

ADA ID: CCRK211118133317 Curb Cut Type: MedianRefuge2

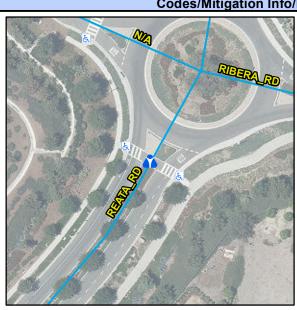
Overall Compliance: No

Field Measurements/Component Compliance							
	Com	pliance Description	Data	Com	pliance Description	Data	
	Yes	Refuge 1 Length (In)	125	Yes	Guttter 1 Ponding	No	
	Yes	Refuge 1 Width (In)	96	Yes	Gutter 1 Lip Ht (In)	0	
	Yes	Refuge 1 Slope (%)	1.1	Yes	Gutter 1 Slope (%)	2	
	Yes	Refuge 1 Cross Slope (%)	2.4	No	Gutter 1 Cross Slope (%)	2.3	
	N/A	Painted Cross Walk 1	Yes	No	DWS 1 Provided	No	
		Cross Walk 1 Direction	W	N/A	DWS 1 Contrast	N/A	
		Cross Walk 1 Width (In)	145	N/A	DWS 1 Length (In)	N/A	
	Yes	Refuge Inside Cross Walk 1	Yes	N/A	DWS 1 Full Width	N/A	
		Road 1 Slope (%)	2.1	N/A	DWS 1 Offset (In)	N/A	
		Road 1 Cross Slope (%)	3.3			N/A	
	Yes	Refuge 2 Length (In)	125	Yes	Guttter 2 Ponding	No	
	Yes	Refuge 2 Width (In)	96	Yes	Gutter 2 Lip Ht (In)	0	
	Yes	Refuge 2 Slope (%)	0.2	Yes	Gutter 2 Slope (%)	2	
	Yes	Refuge 2 Cross Slope (%)	2.4	No	Gutter 2 Cross Slope (%)	3.7	
1704	N/A	Painted Cross Walk 2	Yes	No	DWS 2 Provided	No

Install Detectable Warning System. Remove & Replace Gutter.
