## **Access Compliance Report Public Rights-of-Way** (Island Curb Cuts)

Main Street: FAUNA\_DR Cross Street:CHIQUITA\_CANYON\_DR Location: NE **Severity Score:** ADA ID: CCRK211124124117 Curb Cut Type: MedianRefuge2 **Initial Pass/Fail: Pass Overall Compliance: Yes**

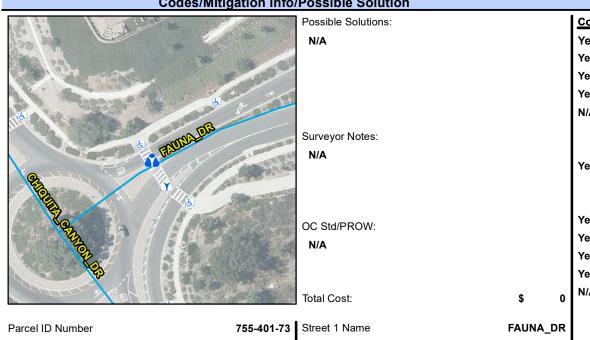
Field Measurements/Component Compliance								
1	Com	pliance Description	Data	Com	pliance Description	Data		
	Yes	Refuge 1 Length (In)	65	Yes	Guttter 1 Ponding	No		
	Yes	Refuge 1 Width (In)	96	Yes	Gutter 1 Lip Ht (In)	0		
	Yes	Refuge 1 Slope (%)	2.1	Yes	Gutter 1 Slope (%)	0.7		
	Yes	Refuge 1 Cross Slope (%)	0.4	Yes	Gutter 1 Cross Slope (%)	0.2		
	N/A	Painted Cross Walk 1	Yes	Yes	DWS 1 Provided	Yes		
		Cross Walk 1 Direction	SE	Yes	DWS 1 Contrast	Yes		
		Cross Walk 1 Width (In)	150	Yes	DWS 1 Length (In)	36		
	Yes	Refuge Inside Cross Walk 1	Yes	Yes	DWS 1 Full Width	Yes		
		Road 1 Slope (%)	0.3	Yes	DWS 1 Offset (In)	0		
		Road 1 Cross Slope (%)	0.4			N/A		
	Yes	Refuge 2 Length (In)	64	Yes	Guttter 2 Ponding	No		
	Yes	Refuge 2 Width (In)	96	Yes	Gutter 2 Lip Ht (In)	0		
	Yes	Refuge 2 Slope (%)	1.2	Yes	Gutter 2 Slope (%)	2.7		
	Yes	Refuge 2 Cross Slope (%)	3.8	Yes	Gutter 2 Cross Slope (%)	1.7		
	N/A	Painted Cross Walk 2	Yes	Yes	DWS 2 Provided	Yes

Cross Walk 2 Direction	N	Yes	DWS 2 Contrast	Yes		
2		Cross Walk 2 Width (In)	150	Yes	DWS 2 Length (In)	36		
١.	Yes	Refuge Inside Cross Walk 2	Yes	Yes	DWS 2 Full Width	Yes		
2		Road 2 Slope (%)	2.9	Yes	DWS 2 Offset (In)	0		
١		Road 2 Cross Slope (%)	1.4					
	Yes	Overall Surface Condition: Acce	ptable
