# Access Compliance Report Public Rights-of-Way (Island Curb Cuts)

Main Street: CHIQUITA\_CANYON\_DR Cross Street: CHIQUITA\_CANYON\_DR Location: S

ADA ID: CCRK211124125442 Curb Cut Type: MedianRefuge2 Initial Pass/Fail: Pass Overall Compliance: No Severity Score: 10

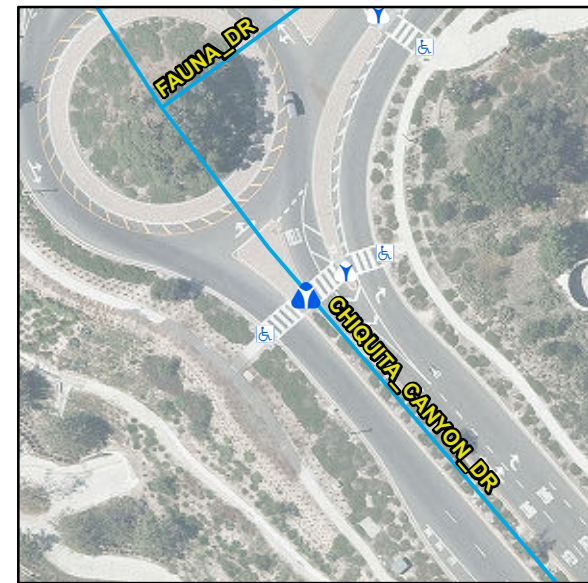
| Compliance | Description | Data | Compliance | Description | Data |
|---|---|---|---|---|---|
| Yes | Refuge 2 Slope (%) | 0.9 | No | Gutter 2 Slope (%) | 7.3 |

Remove & Replace Gutter.

R304.5.4, STD 1115

Total Cost: \$ 252
