# Access Compliance Report Public Rights-of-Way (Island Curb Cuts)

| Main Street: FAUNA_DR | | Cross Street: CHIQUITA_CANYON_DR | | Location: | S |
| ADA ID: CCRK211124125639 | Curb Cut Type: MedianRefuge2 | Initial Pass/Fail: Pass | Overall Compliance: No | Severity Score: | 10 |

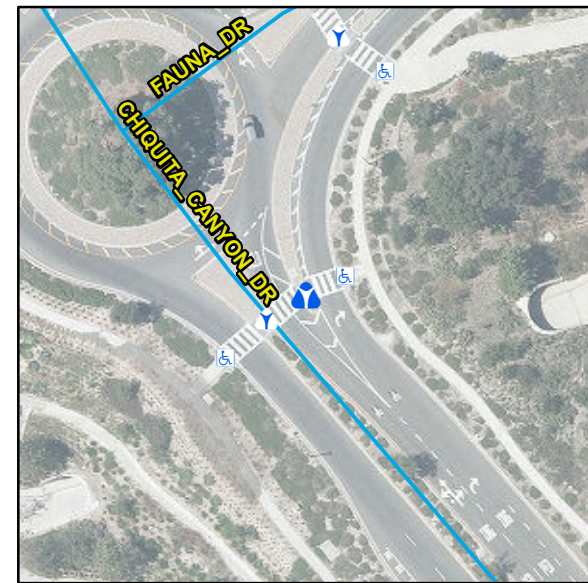
| Compliance | Description | Data | Compliance | Description | Data |
|---|---|---|---|---|---|
| No | Refuge 1 Length (In) | 34 | Yes | Guttter 1 Ponding | No |
| Yes | Refuge 1 Slope (%) | 3.6 | No | Gutter 1 Slope (%) | 5.8 |
| Yes | Refuge 1 Cross Slope (%) | 2.7 | No | Gutter 1 Cross Slope (%) | 2.1 |
| No | Refuge 2 Length (In) | 34 | Yes | Guttter 2 Ponding | No |
| Yes | Refuge 2 Slope (%) | 3.7 | No | Gutter 2 Slope (%) | 6.8 |

**Remove & Replace Entire Refuge. Remove & Replace Gutter.**
