# Access Compliance Report Public Rights-of-Way (Island Curb Cuts)

| Main Street: CHIQUITA_CANYON_DR | | Cross Street: CHIQUITA_CANYON_DR | | Location: | S |
| ADA ID: CCRK211124131450 | Curb Cut Type: MedianRefuge2 | Initial Pass/Fail: Fail | Overall Compliance: No | Severity Score: | 15 |

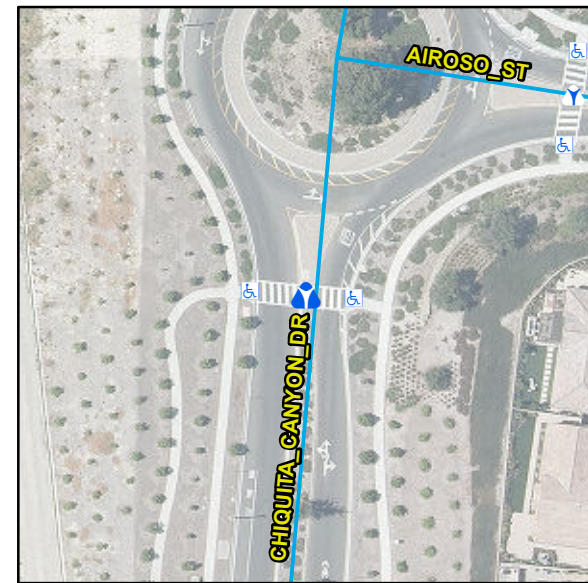
| Compliance | Description | Data | Compliance | Description | Data |
|---|---|---|---|---|---|
| No | Refuge 1 Slope (%) | 5.7 | N/A | Gutter 1 Slope (%) | N/A |
| No | Refuge 2 Slope (%) | 5.1 | N/A | Gutter 2 Slope (%) | N/A |

Remove & Replace Entire Refuge.

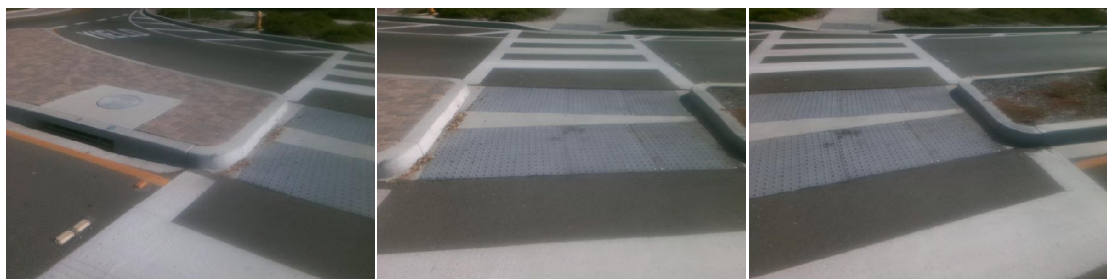
| Compliance | Description | Data | Compliance | Description | Data |
|---|---|---|---|---|---|
| Yes | Obstructions Present? | No | N/A | Utilities Present? | No |
