## **Access Compliance Report Public Rights-of-Way** (Island Curb Cuts)

Main Street: 17TH\_ST **Cross Street:NEWPORT\_AVE** Location: NW ADA ID: CCRK211228155404 Curb Cut Type: MedianRefuge2 Initial Pass/Fail: Fail **Overall Compliance: No Severity Score:** 12.5

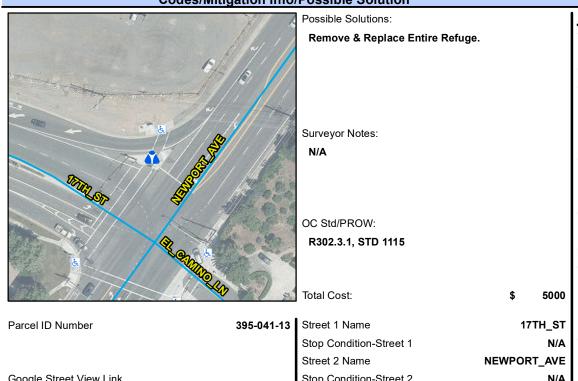
Field Measurements/Component Compliance								
1	Com	pliance Description	Data	Com	pliance Description	Data		
	Yes	Refuge 1 Length (In)	100	N/A	Guttter 1 Ponding	N/A		
	No	Refuge 1 Width (In)	34	Yes	Gutter 1 Lip Ht (In)	0		
	Yes	Refuge 1 Slope (%)	1.1	N/A	Gutter 1 Slope (%)	N/A		
	Yes	Refuge 1 Cross Slope (%)	0.6	N/A	Gutter 1 Cross Slope (%)	N/A		
	N/A	Painted Cross Walk 1	Yes	N/A	DWS 1 Provided	N/A		
		Cross Walk 1 Direction	N	N/A	DWS 1 Contrast	N/A		
		Cross Walk 1 Width (In)	144	N/A	DWS 1 Length (In)	N/A		
	Yes	Refuge Inside Cross Walk 1	Yes	N/A	DWS 1 Full Width	N/A		
		Road 1 Slope (%)	1.2	N/A	DWS 1 Offset (In)	N/A		
		Road 1 Cross Slope (%)	4.1			N/A		
	Yes	Refuge 2 Length (In)	100	N/A	Guttter 2 Ponding	N/A		
	No	Refuge 2 Width (In)	34	Yes	Gutter 2 Lip Ht (In)	0		
	Yes	Refuge 2 Slope (%)	1.1	N/A	Gutter 2 Slope (%)	N/A		
	Yes	Refuge 2 Cross Slope (%)	1	N/A	Gutter 2 Cross Slope (%)	N/A		
,	N/A	Painted Cross Walk 2	Yes	N/A	DWS 2 Provided	N/A

Cross Walk 2 Direction	W	N/A	DWS 2 Contrast	N/A		
•		Cross Walk 2 Width (In)	144	N/A	DWS 2 Length (In)	N/A		
۱	Yes	Refuge Inside Cross Walk 2	Yes	N/A	DWS 2 Full Width	N/A		
:		Road 2 Slope (%)	1.2	N/A	DWS 2 Offset (In)	N/A		
۱		Road 2 Cross Slope (%)	8.0					
	Yes	Overall Surface Condition: Accep	ptable					
				J
