# Access Compliance Report Public Rights-of-Way (Island Curb Cuts)

Main Street: CARBON\_CANYON\_RD Cross Street: VALENCIA\_AVE Location: SE

ADA ID: CCRK220201121941 Curb Cut Type: IslandRefuge3 Initial Pass/Fail: Pass Overall Compliance: No Severity Score: 25

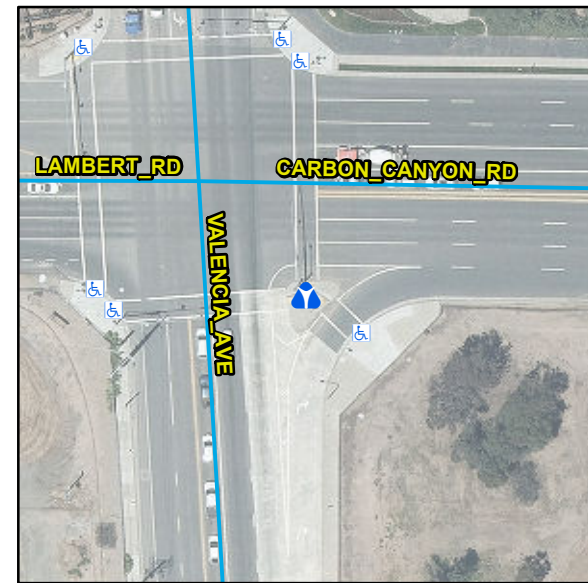
| Compliance | Description | Data | Compliance | Description | Data |
|---|---|---|---|---|---|
| | Road 1 Slope (%) | 2.9 | No | DWS 1 Offset (In) | 4 |
| | Road 2 Slope (%) | 0.4 | No | DWS 2 Offset (In) | 6 |
| | Road 3 Slope (%) | 2.9 | No | DWS 3 Offset (In) | 16 |

**Remove & Replace Detectable Warning System.  
Utility Present.**

**R305.2, STD 1115**

Total Cost: \$ 2400
