Access Compliance Report Public Rights-of-Way (Island Curb Cuts)

Main Street: BOLSA_AVE_FRONTAGE_ROAD Cross Street: PURDY_ST Location:

ADA ID: CCRK220203143945 Curb Cut Type: MedianRefuge2 Initial Pass/Fail: Fail Overall Compliance: No Severity Score: 21.25

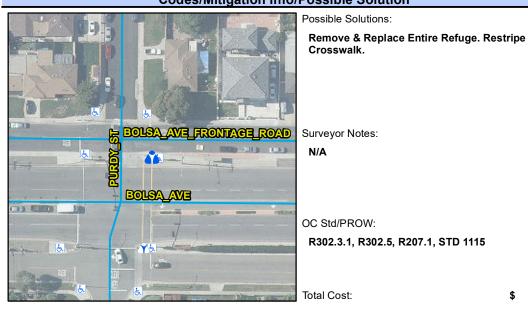
Field Measurements/Component Compliance							
Com	pliance Description	Data	Com	pliance Description	Data		
Yes	Refuge 1 Length (In)	44	N/A	Guttter 1 Ponding	N/A		
No	Refuge 1 Width (In)	48	Yes	Gutter 1 Lip Ht (In)	0		
No	Refuge 1 Slope (%)	5.5	N/A	Gutter 1 Slope (%)	N/A		
Yes	Refuge 1 Cross Slope (%)	1.9	N/A	Gutter 1 Cross Slope (%)	N/A		
N/A	Painted Cross Walk 1	No	N/A	DWS 1 Provided	N/A		
	Cross Walk 1 Direction	N	N/A	DWS 1 Contrast	N/A		
	Cross Walk 1 Width (In)	N/A	N/A	DWS 1 Length (In)	N/A		
N/A	Refuge Inside Cross Walk 1	N/A	N/A	DWS 1 Full Width	N/A		
	Road 1 Slope (%)	1.1	N/A	DWS 1 Offset (In)	N/A		
	Road 1 Cross Slope (%)	0.2			N/A		
Yes	Refuge 2 Length (In)	44	N/A	Guttter 2 Ponding	N/A		
No	Refuge 2 Width (In)	48	Yes	Gutter 2 Lip Ht (In)	0		
Yes	Refuge 2 Slope (%)	1.4	N/A	Gutter 2 Slope (%)	N/A		
Yes	Refuge 2 Cross Slope (%)	0.1	N/A	Gutter 2 Cross Slope (%)	N/A		
N/A	Painted Cross Walk 2	Yes	N/A	DWS 2 Provided	N/A
