Access Compliance Report Public Rights-of-Way (Curb Ramps)

Main Street: **HAMER_LN** Cross Street: **YORBA_LINDA_BLV** Location: **SW**

ADA ID: **RPAT210917133107** Ramp Type: **Type 1 - Perpendicular Diagonal Initial Pass/Fail: Pass** Overall Compliance: **No** Severity Score: **6**

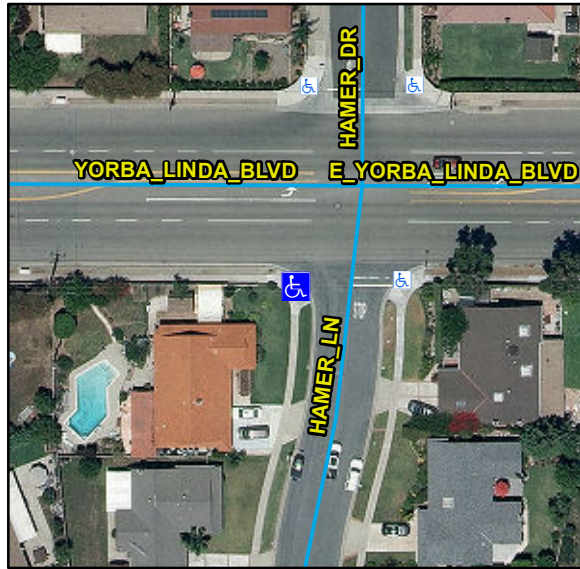
Compliance	Description	Data	Compliance	Description	Data
N/A	Ramp Length (in)	59	N/A	Flare Type LT	
Yes	Ramp Width (in)	48		Flare Slope LT (%)	2.1
Yes	Ramp Run Slope (%)	5.5	N/A	Flare Traversable LT	No
Yes	Ramp Cross Slope (%)	1.8	N/A	Flare Type RT	
N/A	Landing Present	Yes		Flare Slope RT (%)	8.2
N/A	Landing Length (in)	50		Flare Traversable RT	No
Yes	Landing Width (in)	48	N/A	DWS Provided	Yes
No	Landing Run Slope (%)	2.3	N/A	DWS Contrast	Yes
Yes	Landing Cross Slope (%)	1.9	Yes	DWS Length (in)	36
N/A	Landing Movement Obstructed?	Yes	Yes	DWS Full Width	Yes
	Landing Movement Type	Curb	Yes	DWS Offset Left (in)	0
N/A	Landing Shared	No	Yes	DWS Offset Right (in)	N/A
N/A	Clear Space	Yes	N/A	Marked Crosswalk 2	No
N/A	Clear Space To Crosswalk (in)	48	Yes	Crossing 1 Direction	E
N/A	Marked Crosswalk 1	No	N/A	Crossing 2 Direction	N
	Crossing 1 Width (in)	N/A		Marked Crosswalk 2 Width (in)	N/A
N/A	Marked Crosswalk 1 Width (in)	N/A	Yes	Ramp Inside Crosswalk 2	N/A

N/A	Ramp Inside Crosswalk 1	N/A		Crossing 1 Slope (%)	3.8
	Crossing 1 Slope (%)	3.8		Crossing 2 Slope (%)	8.7
	Crossing 1 Cross Slope (%)	3.7		Crossing 2 Cross Slope (%)	1
Yes	Gutter Ponding	No	No	Curb Slope	5.3
Yes	Gutter Lip Height (in)	0		Road Run Slope (%)	3.5
No	Gutter Run Slope (%)	6.4		Road Cross Slope (%)	3.3
Yes	Gutter Cross Slope (%)	1.7			
Yes	Overall Surface Condition: Acceptable		Yes	Perp Joint Present	Yes
	Cross Gutter Present?	No		Spandrel Present?	No
	Replace Cross Gutter?	N/A		Replace Spandrel?	N/A

Possible Solutions:
Remove & Replace Curb Ramp With Two New Directional Ramps or Equivalent. Remove & Replace Gutter.
