# Access Compliance Report Public Rights-of-Way (Curb Ramps)

Main Street: E\_YORBA\_LINDA\_BLV D Cross Street: HAMER\_LN Location: SE

ADA ID: RPAT210917133630 Ramp Type:Type 1 - Perpendicular Diagonal Initial Pass/Fail: Fail Overall Compliance: No Severity Score: 2

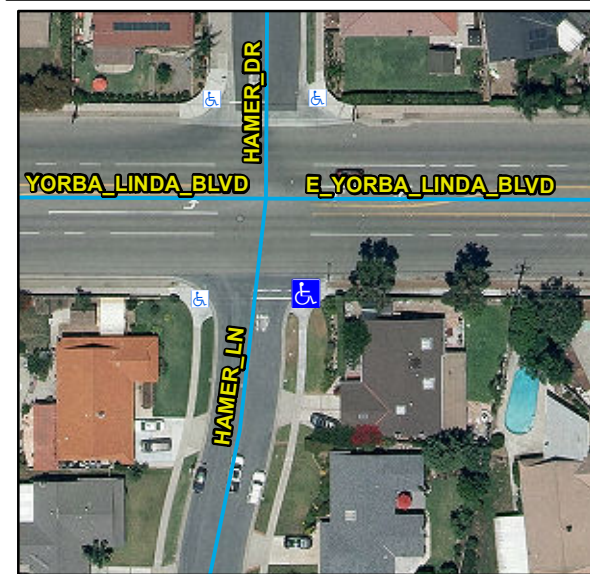
| Compliance | Description | Data | Compliance | Description | Data |
|---|---|---|---|---|---|
| No | Ramp Cross Slope (%) | 2.4 | N/A | Flare Traversable LT | N/A |

Possible Solutions:  
**Remove & Replace Curb Ramp With Two New Directional Ramps or Equivalent.**

OC Std/PROW:  
**R304.2.2, R304.5.3, STD 1115**

Total Cost: \$ 6160
