# Access Compliance Report Public Rights-of-Way (Curb Ramps)

| Main Street: VALENCIA_AVE | | Cross Street: BIRCH_ST | | Location: | NW |
| ADA ID: RPAT210920144940 | Ramp Type:Type 1 - Perpendicular | Initial Pass/Fail: Pass | Overall Compliance: No | Severity Score: | 5 |

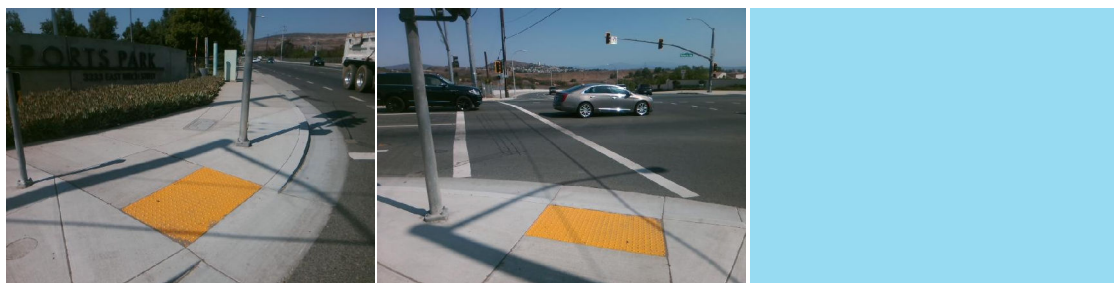
| Obstruction and Utility Measurement/Component Compliance | | | | | |
|---|---|---|---|---|---|
| Yes | Obstructions Present? | No | N/A | Utilities Present? | Yes |
| | Obstruction Dimensions | N/A | | Traffic Signal Pole | |

| Compliance | Description | Data | Compliance | Description | Data |
|---|---|---|---|---|---|
| No | Landing Cross Slope (%) | 5.5 | Yes | DWS Provided | Yes |
| Yes | Gutter Ponding | No | No | Curb Slope | 9.4 |

| | Remove & Replace Entire Ramp. Utility Present. | | | | |
