# Access Compliance Report Public Rights-of-Way (Curb Ramps)

Main Street: **BIRCH\_ST** Cross Street: **VALENCIA\_AVE** Location: **NW**

ADA ID: **RPAT210920145301** Ramp Type: **Type 1 - Perpendicular** Initial Pass/Fail: **Fail** Overall Compliance: **No** Severity Score: **15**

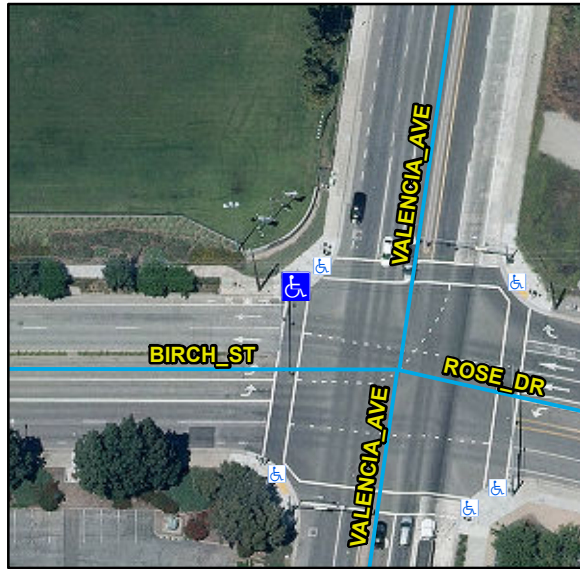
| Compliance | Description | Data | Compliance | Description | Data |
|---|---|---|---|---|---|
| <b>No</b> | Ramp Cross Slope (%) | <b>5.2</b> | <b>N/A</b> | Flare Traversable LT | <b>N/A</b> |

**Remove & Replace Entire Ramp.**

**R304.5.3, STD 1115**
