# Access Compliance Report Public Rights-of-Way (Curb Ramps)

| Main Street: YORBA_LINDA_BLV | | Cross Street: N/A | | Location: | SW |
| ADA ID: RPAT210923080815 | Ramp Type: Type 4 - Parallel | Initial Pass/Fail: Fail | Overall Compliance: No | Severity Score: | 15 |

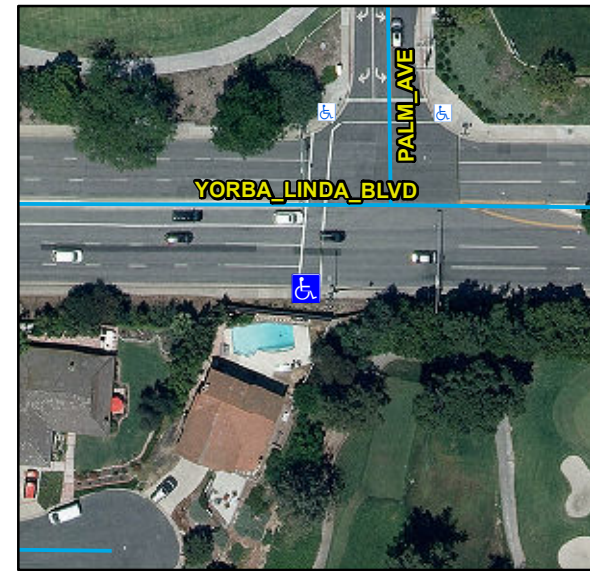
R304.3.2, STD 1115

| Compliance | Description | Data | Compliance | Description | Data |
|---|---|---|---|---|---|
| Yes | Ramp Run Slope LT (%) | 2 | No | Ramp Run Slope RT (%) | 10.1 |

Remove & Replace Entire Ramp.
