# Access Compliance Report Public Rights-of-Way (Curb Ramps)

| Main Street: VISTA_LOMA | | Cross Street: ESPERANZA_RD | | Location: | NE |
| ADA ID: RPAT210923133112 | Ramp Type:Type 1 - Perpendicular | Initial Pass/Fail: Fail | Overall Compliance: No | Severity Score: | 15 |

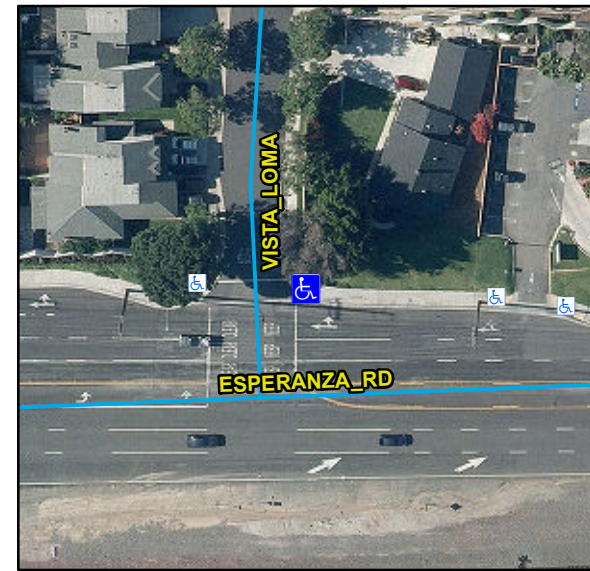
| Compliance | Description | Data | Compliance | Description | Data |
|---|---|---|---|---|---|
| No | Ramp Run Slope (%) | 9.4 | N/A | Flare Slope LT (%) | N/A |
| N/A | Gutter Ponding | N/A | No | Curb Slope | 10.3 |

**Remove & Replace Entire Ramp.**

**R304.2.2, STD 1115**

Total Cost: \$ 3080
