# Access Compliance Report Public Rights-of-Way (Curb Ramps)

Main Street: VISTA\_LOMA Cross Street: ESPERANZA\_RD Location: NW

ADA ID: RPAT210923133409 Ramp Type: Type 1 - Perpendicular Initial Pass/Fail: Fail Overall Compliance: No Severity Score: 15

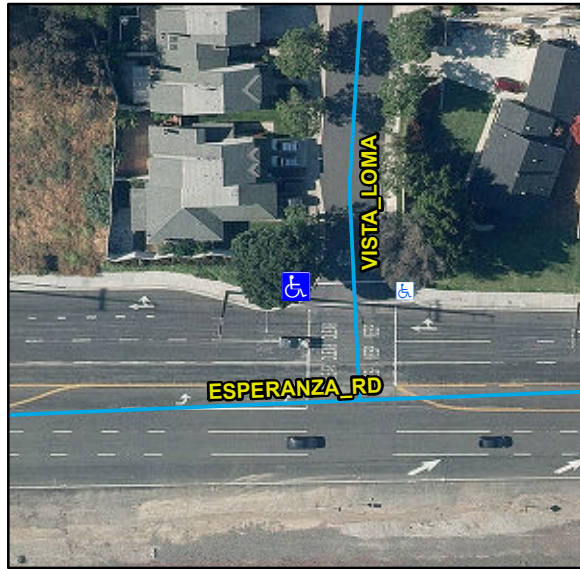
| Compliance | Description | Data | Compliance | Description | Data |
|---|---|---|---|---|---|
| No | Ramp Run Slope (%) | 8.4 | N/A | Flare Slope LT (%) | N/A |

Remove & Replace Entire Ramp.
