# Access Compliance Report Public Rights-of-Way (Curb Ramps)

| Main Street: N/A | | Cross Street: ESPERANZA_RD | | Location: | NE |
| ADA ID: RPAT210923133953 | Ramp Type:Type 1 - Perpendicular | Initial Pass/Fail: Fail | Overall Compliance: No | Severity Score: | 30 |

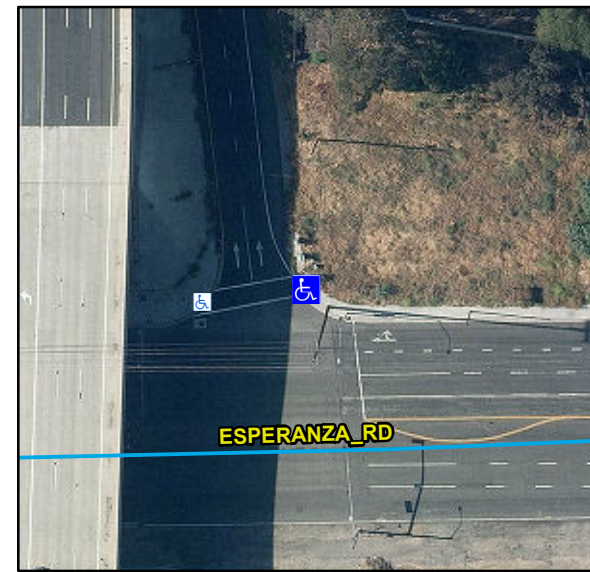
| Compliance | Description | Data | Compliance | Description | Data |
|---|---|---|---|---|---|
| No | Ramp Run Slope (%) | 9.1 | N/A | Flare Slope LT (%) | N/A |
| No | Overall Surface Condition: | Poor | Yes | Perp Joint Present | Yes |

Remove & Replace Entire Ramp.

R304.2.2, R302.7, STD 1115
