# Access Compliance Report Public Rights-of-Way (Curb Ramps)

Main Street: N\_GAYLE\_ST Cross Street: BIXBY\_AVE Location: NW

ADA ID: RPAT210924121705 Ramp Type: Type 1 - Perpendicular Initial Pass/Fail: Fail Overall Compliance: No Severity Score: 32

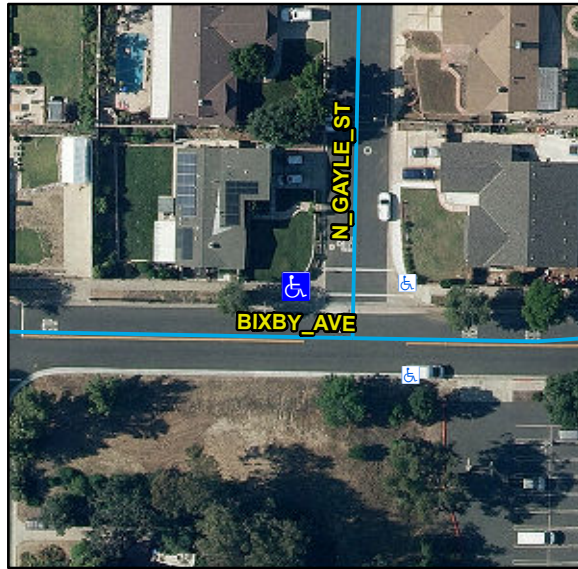
R304.2.2, R204.3, R304.5.3, STD 1115

| Compliance | Description | Data | Compliance | Description | Data |
|---|---|---|---|---|---|
| No | Ramp Run Slope (%) | 13 | N/A | Flare Slope LT (%) | N/A |
| No | Ramp Cross Slope (%) | 2.9 | N/A | Flare Traversable LT | N/A |

Remove & Replace Entire Ramp. Restripe Crosswalk.
