# Access Compliance Report Public Rights-of-Way (Curb Ramps)

| Main Street: N_OCEAN_VIEW_ST | | Cross Street: BIXBY_AVE | | Location: | NW |
| ADA ID: RPAT210924123014 | Ramp Type:Type 1 - Perpendicular | Initial Pass/Fail: Fail | Overall Compliance: No | Severity Score: | 15 |

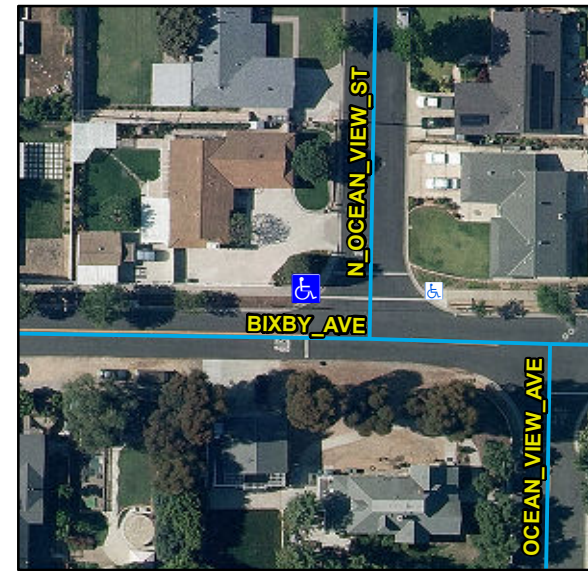
| Compliance | Description | Data | Compliance | Description | Data |
|---|---|---|---|---|---|
| No | Ramp Run Slope (%) | 9.3 | N/A | Flare Slope LT (%) | N/A |
| N/A | Ramp Inside Crosswalk 1 | No | Yes | Ramp Inside Crosswalk 2 | N/A |

**Remove & Replace Entire Ramp. Restripe Crosswalk.**

**R304.2.2, R204.3, STD 1115**

Total Cost: \$ 7080
