# Access Compliance Report Public Rights-of-Way (Curb Ramps)

| Main Street: MAGNOLIA_AVE | | Cross Street: BIXBY_AVE | | Location: | NE |
| ADA ID: RPAT210924125725 | Ramp Type: Type 6 - Directional 1 | Initial Pass/Fail: Fail | Overall Compliance: No | Severity Score: | 30 |

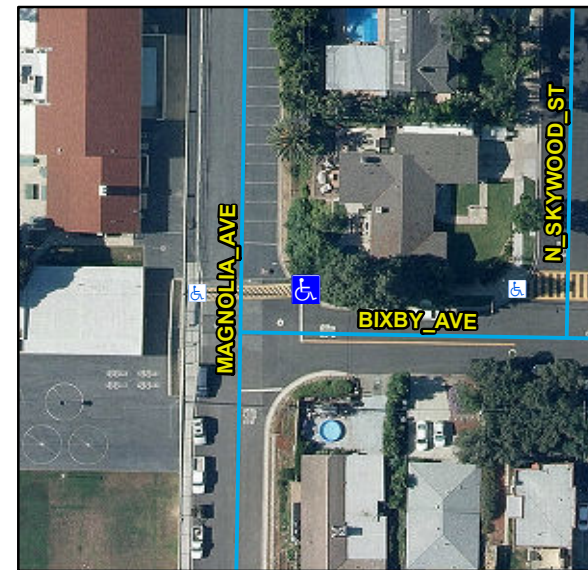
R304.2.2, STD 1115

| Compliance | Description | Data | Compliance | Description | Data |
|---|---|---|---|---|---|
| No | Ramp Run Slope (%) | 26.3 | N/A | Flare Slope LT (%) | N/A |

Remove & Replace Entire Ramp.

Total Cost: \$ 3080
