# Access Compliance Report Public Rights-of-Way (Curb Ramps)

Main Street: ORANGE\_OLIVE\_RD Cross Street: E\_BUENA\_VISTA\_ST Location: NE

ADA ID: RPAT210924144807 Ramp Type: Type 1 - Perpendicular Initial Pass/Fail: Pass Overall Compliance: No Severity Score: 5

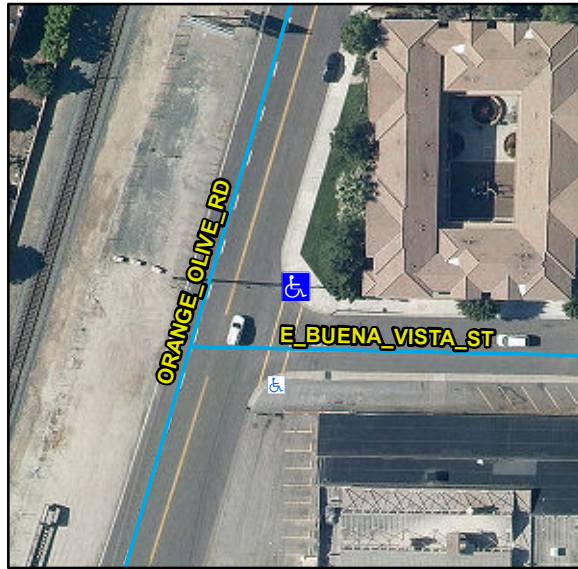
R304.2.2, R304.5.3, R304.5.4, STD 1115

| Compliance | Description | Data | Compliance | Description | Data |
|---|---|---|---|---|---|
| No | Landing Cross Slope (%) | 2.5 | Yes | DWS Provided | Yes |
| Yes | Gutter Ponding | No | No | Curb Slope | 8.4 |
| No | Gutter Run Slope (%) | 8 | | Road Cross Slope (%) | N/A |
| No | Gutter Cross Slope (%) | 2.6 | | | |

Remove & Replace Entire Ramp. Remove & Replace Gutter.
