# Access Compliance Report Public Rights-of-Way (Curb Ramps)

| Main Street: OLIVE_AVE | | Cross Street: E_BUENA_VISTA_ST | | Location: | NE |
| ADA ID: RPAT210924145530 | Ramp Type: Type 4 - Parallel | Initial Pass/Fail: Fail | Overall Compliance: No | Severity Score: | 16 |

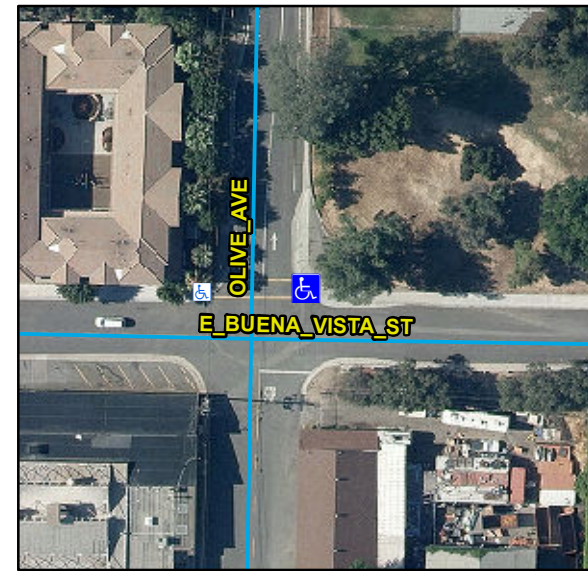
**R304.3.2, STD 1115**

| Compliance | Description | Data | Compliance | Description | Data |
|---|---|---|---|---|---|
| No | Ramp Run Slope LT (%) | 8.5 | Yes | Ramp Run Slope RT (%) | 7.3 |

**Remove & Replace Entire Ramp.**
