# Access Compliance Report Public Rights-of-Way (Curb Ramps)

| Main Street: N_RANCHO_SANTIAGO_BLVD | | Cross Street: E_SYCAMORE_AVE | | Location: | NE |
| ADA ID: RPAT210928085400 | Ramp Type:Type 1 - Perpendicular Diagonal Initial Pass/Fail: Fail | | Overall Compliance: No | Severity Score: | 35 |

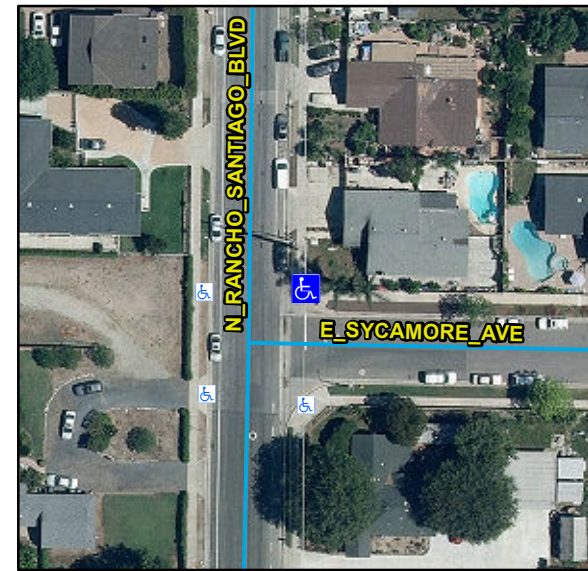
| Compliance | Description | Data | Compliance | Description | Data |
|---|---|---|---|---|---|
| No | Ramp Width (in) | 45 | | | N/A |
| No | Ramp Run Slope (%) | 10.2 | N/A | Flare Slope LT (%) | N/A |
| No | Ramp Cross Slope (%) | 2.2 | N/A | Flare Traversable LT | N/A |
| No | Overall Surface Condition: | Poor | No | Perp Joint Present | No |

**Remove & Replace Curb Ramp With Two New Directional Ramps or Equivalent.**

**R304.2.2, R204.3, R304.5.1, R304.5.3, R302.7, STD 1115**
