# Access Compliance Report Public Rights-of-Way (Curb Ramps)

Main Street: VINE\_ST Cross Street: RANCHO\_SANTIAGO\_BLVD Location: NW

ADA ID: RPAT210928091930 Ramp Type: Type 4 - Parallel Initial Pass/Fail: Fail Overall Compliance: No Severity Score: 16

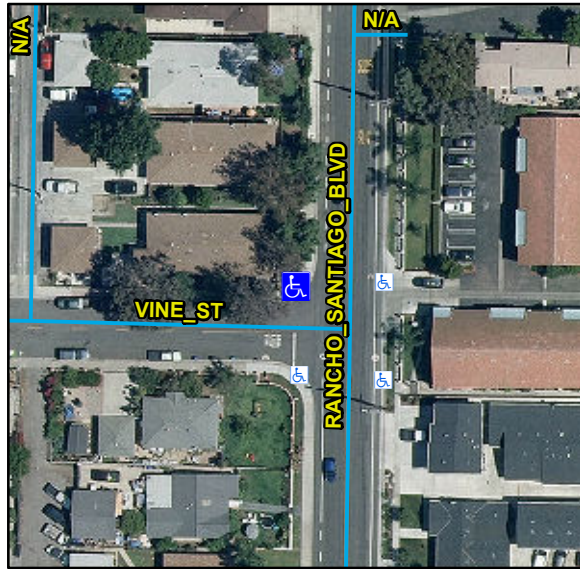
| Compliance | Description | Data | Compliance | Description | Data |
|---|---|---|---|---|---|
| Yes | Ramp Run Slope LT (%) | 1.7 | No | Ramp Run Slope RT (%) | 10.2 |
| Yes | Ramp Cross Slope LT (%) | 1.4 | No | Ramp Cross Slope RT (%) | 2.4 |

**Remove & Replace Curb Ramp With Two New Directional Ramps or Equivalent.**

**R304.3.2, R304.5.3, STD 1115**
