Access Compliance Report Public Rights-of-Way (Curb Ramps)

Main Street: RANCHO_SANTIAGO_BLV **Cross Street:** VINE_ST **Location:** SW

ADA ID: RPAT210928092246 **Ramp Type:** Type 4 - Parallel **Initial Pass/Fail:** Fail **Overall Compliance:** No **Severity Score:** 16

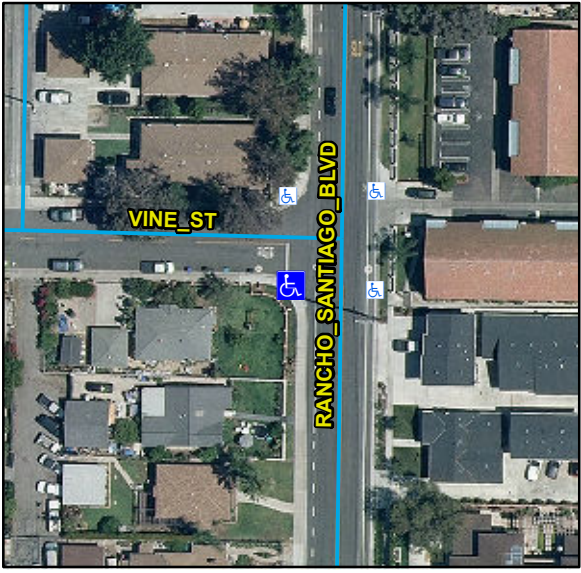
Compliance	Description	Data	Compliance	Description	Data
N/A	Ramp Length LT (in)	97	N/A	Ramp Length RT (in)	107
Yes	Ramp Width LT (in)	48	Yes	Ramp Width RT (in)	48
No	Ramp Run Slope LT (%)	11.1	Yes	Ramp Run Slope RT (%)	1.3
No	Ramp Cross Slope LT (%)	2.3	Yes	Ramp Cross Slope RT (%)	0.1
N/A	Landing Present	N/A	N/A	DWS Provided	N/A
N/A	Landing Length (in)	N/A	N/A	DWS Contrast	N/A
N/A	Landing Width (in)	N/A	N/A	DWS Length (in)	N/A
N/A	Landing Run Slope (%)	N/A	N/A	DWS Full Width	N/A
N/A	Landing Cross Slope (%)	N/A		DWS Offset Type	N/A
N/A	Landing Movement Obstructed?	N/A	N/A	DWS Offset Left (in)	N/A
	Landing Movement Type	N/A	N/A	DWS Offset Right (in)	N/A
N/A	Landing Shared	N/A			
N/A	Clear Space	Yes			
N/A	Clear Space To Crosswalk (in)	N/A			
N/A	Marked Crosswalk 1	No	N/A	Marked Crosswalk 2	No
	Crossing 1 Direction	E		Crossing 2 Direction	N
N/A	Marked Crosswalk 1 Width (in)	N/A	N/A	Marked Crosswalk 2 Width (in)	N/A

N/A	Ramp Inside Crosswalk 1	N/A	N/A	Ramp Inside Crosswalk 2	N/A
	Crossing 1 Slope (%)	8.3		Crossing 2 Slope (%)	2.9
	Crossing 1 Cross Slope (%)	1.2		Crossing 2 Cross Slope (%)	7.3
N/A	Gutter Ponding	N/A	N/A	Curb Slope	6.8
Yes	Gutter Lip Height (in)	0		Road Run Slope (%)	4.8
N/A	Gutter Run Slope (%)	N/A		Road Cross Slope (%)	6.1
N/A	Gutter Cross Slope (%)	N/A	Yes	Perpendicular Joint Present	Yes
Yes	Overall Surface Condition	Acceptable			
	Cross Gutter Present?	No		Spandrel Present?	No
	Replace Cross Gutter?	N/A		Replace Spandrel?	N/A

Possible Solutions:
Remove & Replace Curb Ramp With Two New Directional Ramps or Equivalent.

OC Std/PROW:
 R304.3.2, R304.5.3, STD 1115

Total Cost: \$ 4000
