# Access Compliance Report Public Rights-of-Way (Curb Ramps)

Main Street: S\_RANCHO\_SANTIAGO\_BLVD Cross Street: E\_CENTER\_ST Location: NE

ADA ID: RPAT210928100845 Ramp Type: Type 1 - Perpendicular Diagonal Initial Pass/Fail: Pass Overall Compliance: No Severity Score: 4

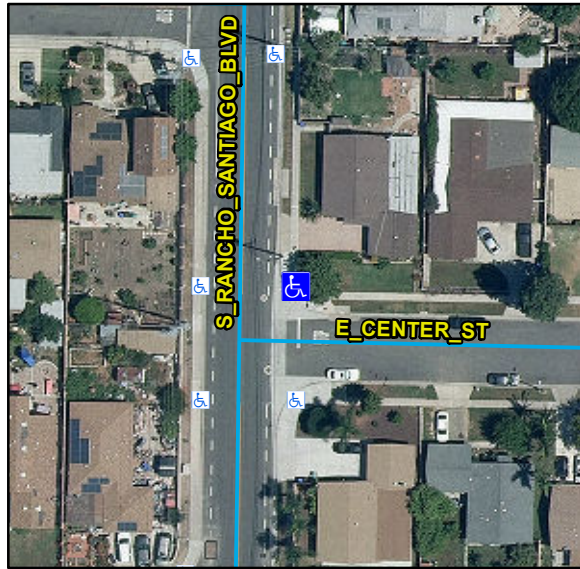
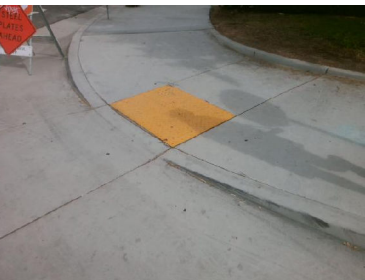
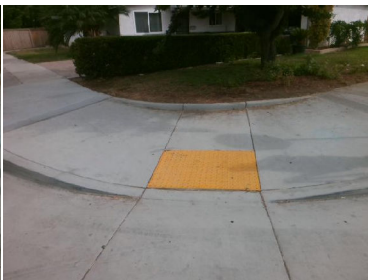
R304.2.2, R304.2.1, STD 1115

| Compliance | Description | Data | Compliance | Description | Data |
|---|---|---|---|---|---|
| Yes | Gutter Ponding | No | No | Curb Slope | 6.9 |

Remove & Replace Curb Ramp With Two New Directional Ramps or Equivalent.
