# Access Compliance Report Public Rights-of-Way (Curb Ramps)

| Main Street: ALLEGHENY_DR | | Cross Street: MALENA_DR | | Location: | SE |
| ADA ID: RPAT210930123223 | Ramp Type:Type 1 - Perpendicular Diagonal Initial Pass/Fail: Fail | | Overall Compliance: No | Severity Score: | 2 |

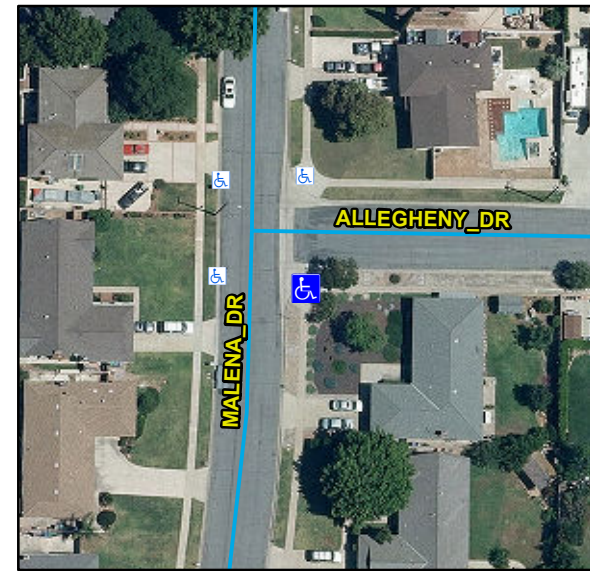
**R304.2.2, R304.5.3, STD 1115**

| Compliance | Description | Data | Compliance | Description | Data |
|---|---|---|---|---|---|
| No | Ramp Cross Slope (%) | 4.9 | N/A | Flare Traversable LT | N/A |

**Remove & Replace Curb Ramp With Two New Directional Ramps or Equivalent.**
