# Access Compliance Report Public Rights-of-Way (Curb Ramps)

Main Street: S\_WOODLAND\_ST Cross Street: LARKSTONE\_DR Location: SW

ADA ID: RPAT211005122308 Ramp Type: Type 1 - Perpendicular Diagonal Initial Pass/Fail: Fail Overall Compliance: No Severity Score: 2

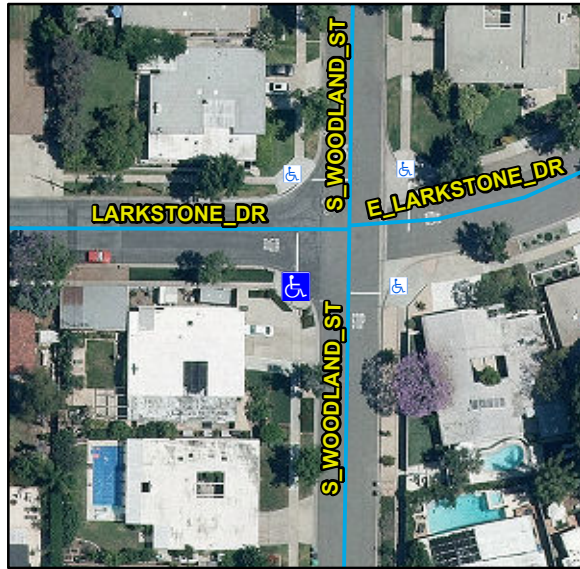
R304.2.2, R304.5.3, STD 1115

| Compliance | Description | Data | Compliance | Description | Data |
|---|---|---|---|---|---|
| No | Ramp Cross Slope (%) | 4.9 | N/A | Flare Traversable LT | N/A |

Remove & Replace Curb Ramp With Two New Directional Ramps or Equivalent.
