# Access Compliance Report Public Rights-of-Way (Curb Ramps)

| Main Street: VANDERLIP_AVE | | Cross Street: VANDERLIP_AVE | | Location: | S |
| ADA ID: RPAT211006091657 | Ramp Type:Type 1 - Perpendicular | Initial Pass/Fail: Fail | Overall Compliance: No | Severity Score: | 15 |

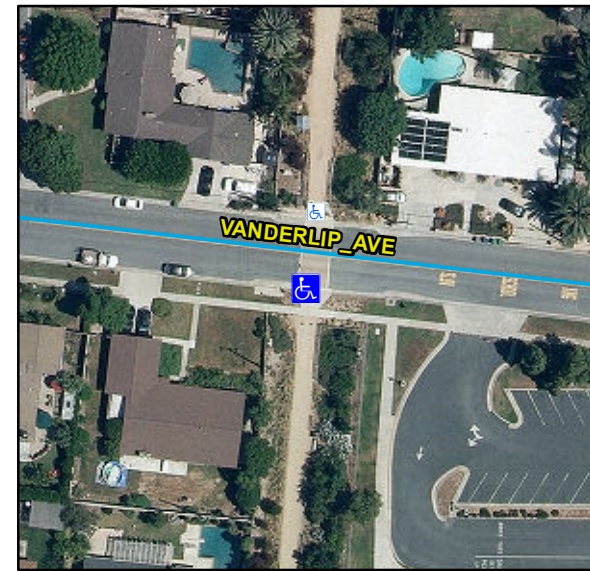
R304.2.2, STD 1115

| Compliance | Description | Data | Compliance | Description | Data |
|---|---|---|---|---|---|
| No | Ramp Run Slope (%) | 12 | N/A | Flare Slope LT (%) | N/A |

Remove & Replace Entire Ramp.
