# Access Compliance Report Public Rights-of-Way (Curb Ramps)

| Main Street: RANCHWOOD_RD | | Cross Street: FAIR_WEATHER_RD | | Location: | W |
| ADA ID: RPAT211013134801 | Ramp Type:Type 1 - Perpendicular Diagonal Initial Pass/Fail: Fail | | Overall Compliance: No | Severity Score: | 15 |

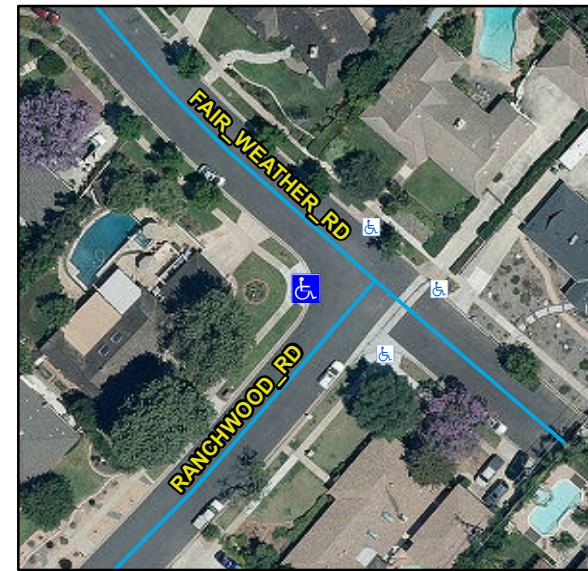
**R304.2.2, R304.5.3, STD 1115**

| Compliance | Description | Data | Compliance | Description | Data |
|---|---|---|---|---|---|
| No | Ramp Cross Slope (%) | 5.3 | N/A | Flare Traversable LT | N/A |

**Remove & Replace Curb Ramp With Two New Directional Ramps or Equivalent.**
