# Access Compliance Report Public Rights-of-Way (Curb Ramps)

Main Street: LEAFWOOD\_LN Cross Street: CARLSBAD\_DR Location: NW

ADA ID: RPAT211019110845 Ramp Type: Type 1 - Perpendicular Diagonal Initial Pass/Fail: Fail Overall Compliance: No Severity Score: 4

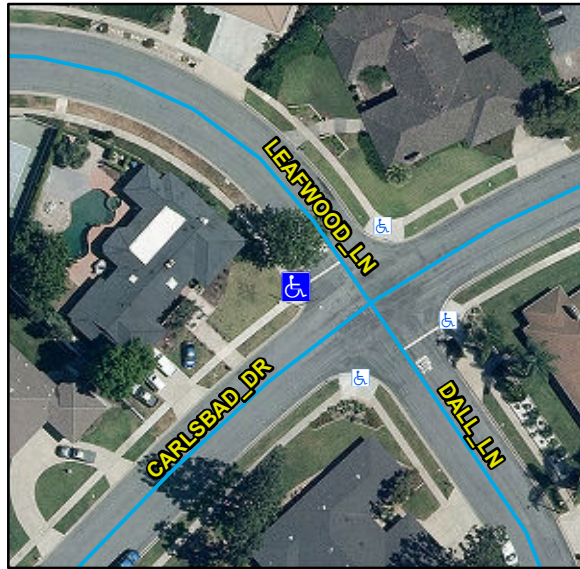
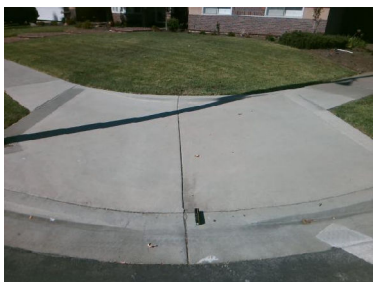
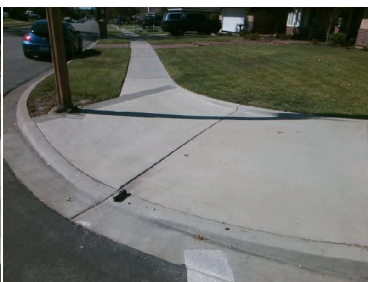
R304.2.2, R304.5.1, STD 1115

| Compliance | Description | Data | Compliance | Description | Data |
|---|---|---|---|---|---|
| No | Ramp Width (in) | 43 | | | N/A |

Remove & Replace Curb Ramp With Two New Directional Ramps or Equivalent.
