# Access Compliance Report Public Rights-of-Way (Curb Ramps)

Main Street: DALL\_LN Cross Street: CARLSBAD\_DR Location: SW

ADA ID: RPAT211019111651 Ramp Type: Type 1 - Perpendicular Diagonal Initial Pass/Fail: Fail Overall Compliance: No Severity Score: 2

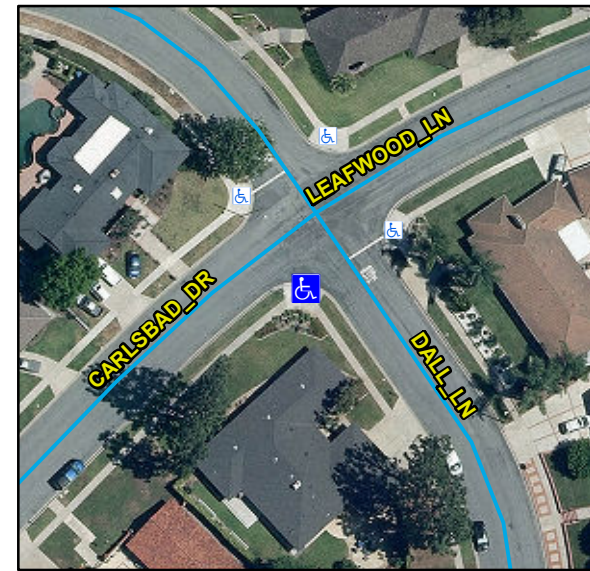
R204.3, R304.5.3, STD 1115

| Compliance | Description | Data | Compliance | Description | Data |
|---|---|---|---|---|---|
| No | Ramp Cross Slope (%) | 2.4 | N/A | Flare Traversable LT | N/A |

Remove & Replace Curb Ramp With Two New Directional Ramps or Equivalent.

Total Cost: \$ 6160
