# Access Compliance Report Public Rights-of-Way (Curb Ramps)

Main Street: E\_EL\_CARMEN\_AVE Cross Street: N\_HAMLIN\_ST Location: NW

ADA ID: RPAT211020081957 Ramp Type: Type 1 - Perpendicular Diagonal Initial Pass/Fail: Fail Overall Compliance: No Severity Score: 32

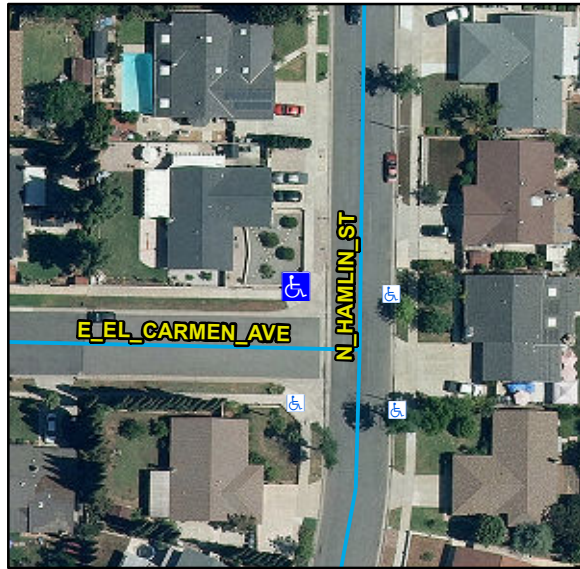
| Compliance | Description | Data | Compliance | Description | Data |
|---|---|---|---|---|---|
| No | Ramp Run Slope (%) | 13.3 | N/A | Flare Slope LT (%) | N/A |
| No | Ramp Cross Slope (%) | 2.4 | N/A | Flare Traversable LT | N/A |

Remove & Replace Curb Ramp With Two New Directional Ramps or Equivalent.
