# Access Compliance Report Public Rights-of-Way (Curb Ramps)

Main Street: N\_HAMLIN\_ST Cross Street: E\_EL\_CARMEN\_AVE Location: SW

ADA ID: RPAT211020082506 Ramp Type: Type 1 - Perpendicular Diagonal Initial Pass/Fail: Fail Overall Compliance: No Severity Score: 19

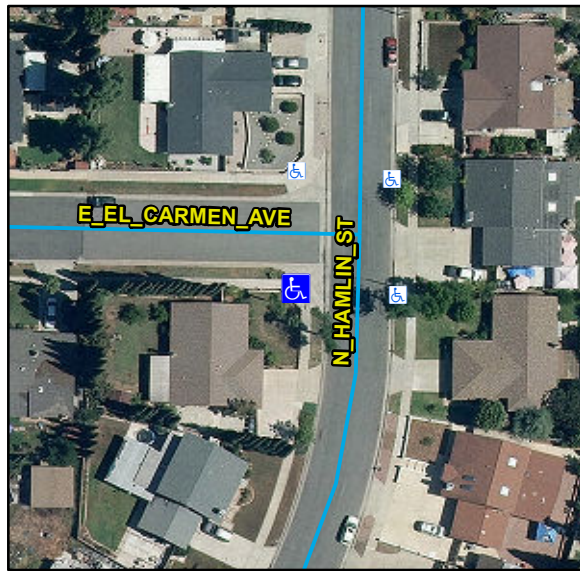
| Compliance | Description | Data | Compliance | Description | Data |
|---|---|---|---|---|---|
| No | Ramp Width (in) | 40 | | | N/A |
| No | Ramp Run Slope (%) | 11 | N/A | Flare Slope LT (%) | N/A |

Remove & Replace Curb Ramp With Two New Directional Ramps or Equivalent.
