# Access Compliance Report Public Rights-of-Way (Curb Ramps)

Main Street: E\_EL\_CARMEN\_AVE Cross Street: S\_CHURCH\_ST Location: NW

ADA ID: RPAT211020092429 Ramp Type: Type 1 - Perpendicular Diagonal Initial Pass/Fail: Fail Overall Compliance: No Severity Score: 2

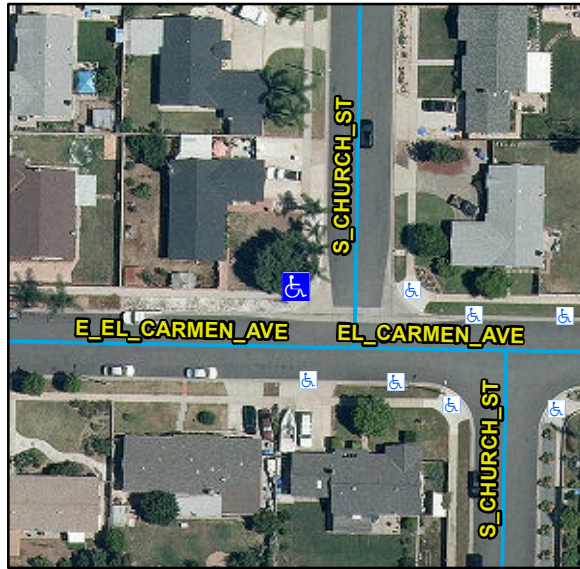
| Compliance | Description | Data | Compliance | Description | Data |
|---|---|---|---|---|---|
| No | Ramp Cross Slope (%) | 3.4 | N/A | Flare Traversable LT | N/A |

**Remove & Replace Curb Ramp With Two New Directional Ramps or Equivalent.**

**R304.5.3, STD 1115**
