# Access Compliance Report Public Rights-of-Way (Curb Ramps)

Main Street: E\_EL\_CARMEN\_AVE Cross Street: EARLHAM\_ST Location: SE

ADA ID: RPAT211020095443 Ramp Type:Type 1 - Perpendicular Diagonal Initial Pass/Fail: Fail Overall Compliance: No Severity Score: 2

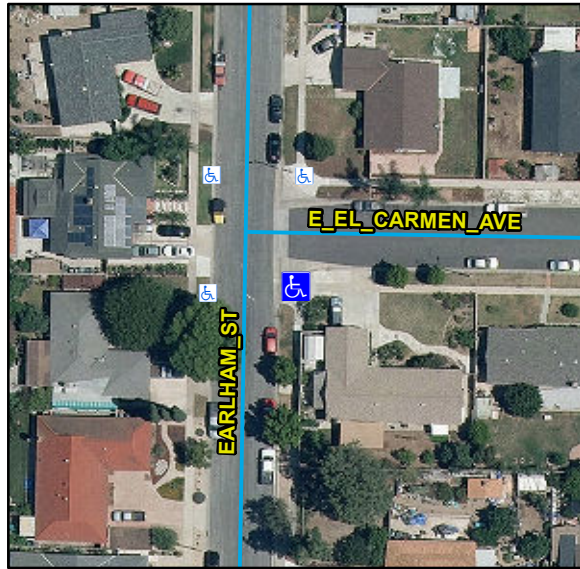
| Compliance | Description | Data | Compliance | Description | Data |
|---|---|---|---|---|---|
| No | Ramp Cross Slope (%) | 4.2 | N/A | Flare Traversable LT | N/A |

Remove & Replace Curb Ramp With Two New Directional Ramps or Equivalent.

R304.2.2, R304.5.3, STD 1115
