# Access Compliance Report Public Rights-of-Way (Curb Ramps)

Main Street: FAIRHAVEN\_AVE Cross Street: MALENA\_DR Location: SW

ADA ID: RPAT211021093743 Ramp Type: Type 1 - Perpendicular Initial Pass/Fail: Fail Overall Compliance: No Severity Score: 15

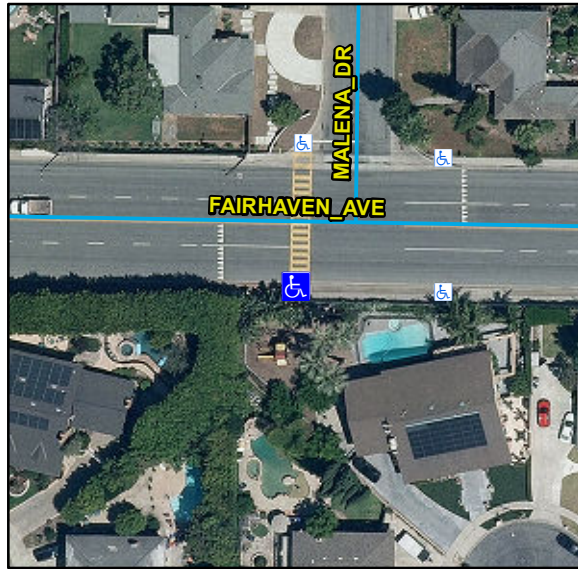
| Compliance | Description | Data | Compliance | Description | Data |
|---|---|---|---|---|---|
| No | Ramp Run Slope (%) | 10.5 | N/A | Flare Slope LT (%) | N/A |

Remove & Replace Entire Ramp.

R304.2.2, STD 1115
