# Access Compliance Report Public Rights-of-Way (Curb Ramps)

Main Street: JOSHUA\_LN Cross Street: DALL\_LN Location: N

ADA ID: RPAT211026145843 Ramp Type: Type 1 - Perpendicular Diagonal Initial Pass/Fail: Fail Overall Compliance: No Severity Score: 2

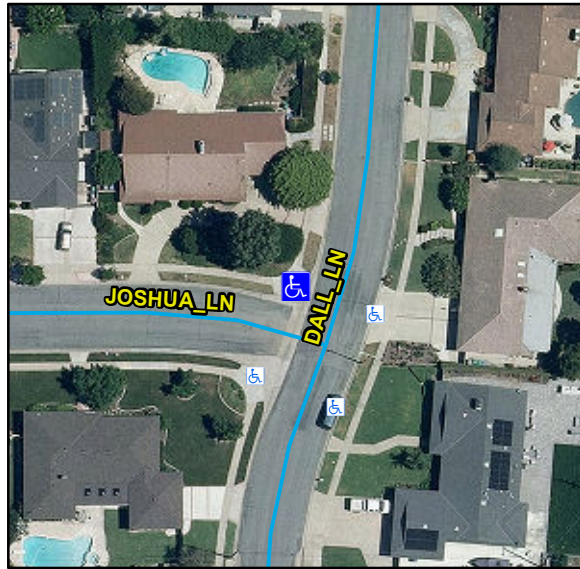
| Compliance | Description | Data | Compliance | Description | Data |
|---|---|---|---|---|---|
| No | Ramp Cross Slope (%) | 2.6 | N/A | Flare Traversable LT | N/A |

Remove & Replace Curb Ramp With Two New Directional Ramps or Equivalent.
