# Access Compliance Report Public Rights-of-Way (Curb Ramps)

Main Street: STERLING\_GLEN Cross Street: LANESBORO\_RD Location: S

ADA ID: RPAT211101134437 Ramp Type: Type 4 - Parallel Initial Pass/Fail: Fail Overall Compliance: No Severity Score: 32

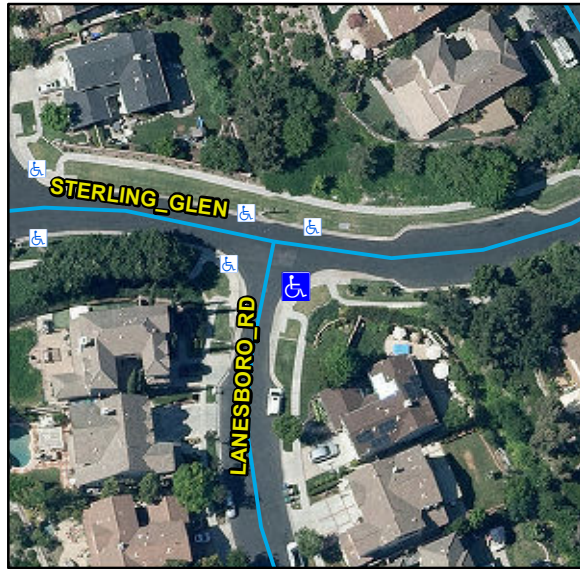
| Compliance | Description | Data | Compliance | Description | Data |
|---|---|---|---|---|---|
| No | Ramp Run Slope LT (%) | 12.7 | Yes | Ramp Run Slope RT (%) | 1.4 |
| No | Ramp Cross Slope LT (%) | 3 | No | Ramp Cross Slope RT (%) | 2.4 |

**Remove & Replace Curb Ramp With Two New Directional Ramps or Equivalent.**
