# Access Compliance Report Public Rights-of-Way (Curb Ramps)

| Main Street: LANESBORO_RD | | Cross Street: STERLING_GLEN | | Location: | SW |
| ADA ID: RPAT211101134821 | Ramp Type: Type 4 - Parallel | Initial Pass/Fail: Fail | Overall Compliance: No | Severity Score: | 15 |

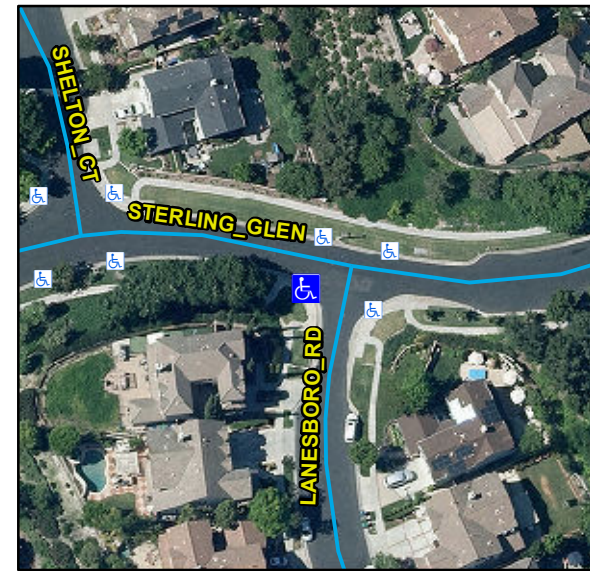
| Compliance | Description | Data | Compliance | Description | Data |
|---|---|---|---|---|---|
| No | Ramp Run Slope LT (%) | 12 | Yes | Ramp Run Slope RT (%) | 4.5 |

**Remove & Replace Curb Ramp With Two New Directional Ramps or Equivalent.**

**R204.3, R304.3.2, STD 1115**
