# Access Compliance Report Public Rights-of-Way (Curb Ramps)

| Main Street: HYDRANGEA_ST | | Cross Street: S_SELLAS_RD | | Location: | SW |
| ADA ID: RPAT211102131935 | Ramp Type:Type 1 - Perpendicular Diagonal Initial Pass/Fail: Fail | | Overall Compliance: No | Severity Score: | 16 |

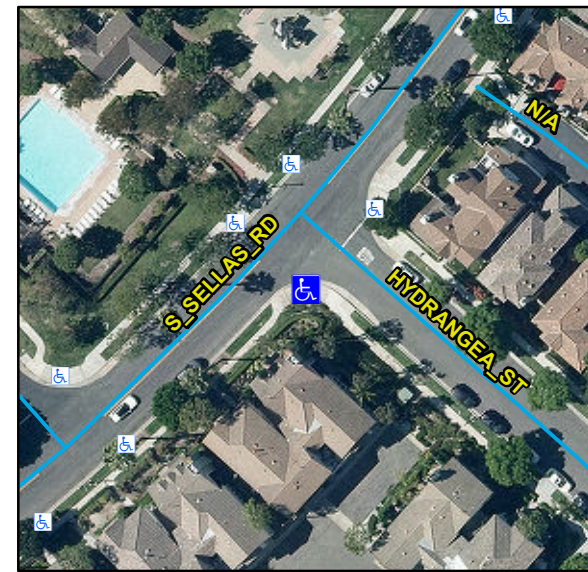
| Compliance | Description | Data | Compliance | Description | Data |
|---|---|---|---|---|---|
| No | Ramp Run Slope (%) | 9.2 | N/A | Flare Slope LT (%) | N/A |
| N/A | Gutter Ponding | N/A | No | Curb Slope | 13.7 |

**Remove & Replace Curb Ramp With Two New Directional Ramps or Equivalent.**

**R304.2.2, R204.3, STD 1115**
