# Access Compliance Report Public Rights-of-Way (Curb Ramps)

Main Street: S\_SELLAS\_RD Cross Street: HYDRANGEA\_ST Location: NW

ADA ID: RPAT211102132130 Ramp Type: Type 1 - Perpendicular Initial Pass/Fail: Fail Overall Compliance: No Severity Score: 32

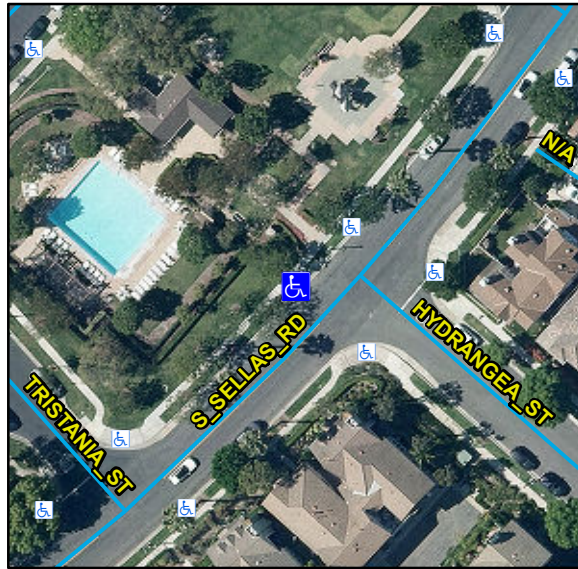
| Compliance | Description | Data | Compliance | Description | Data |
|---|---|---|---|---|---|
| No | Ramp Run Slope (%) | 14.4 | N/A | Flare Slope LT (%) | N/A |
| No | Ramp Cross Slope (%) | 2.3 | N/A | Flare Traversable LT | N/A |

Remove & Replace Entire Ramp.
